# Arizona-Southern California Outages on September 8, 2011

## Causes and Recommendations

Prepared by the Staffs of the  
Federal Energy Regulatory Commission  
*and the*  
North American Electric Reliability Corporation

**April 2012**

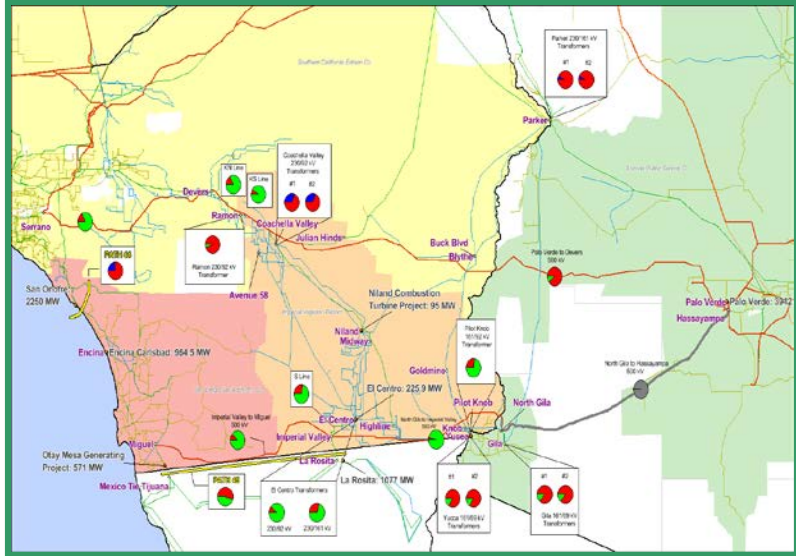
**15:27:39 – The Hassayampa- North Gila 500 kV line tripped.**

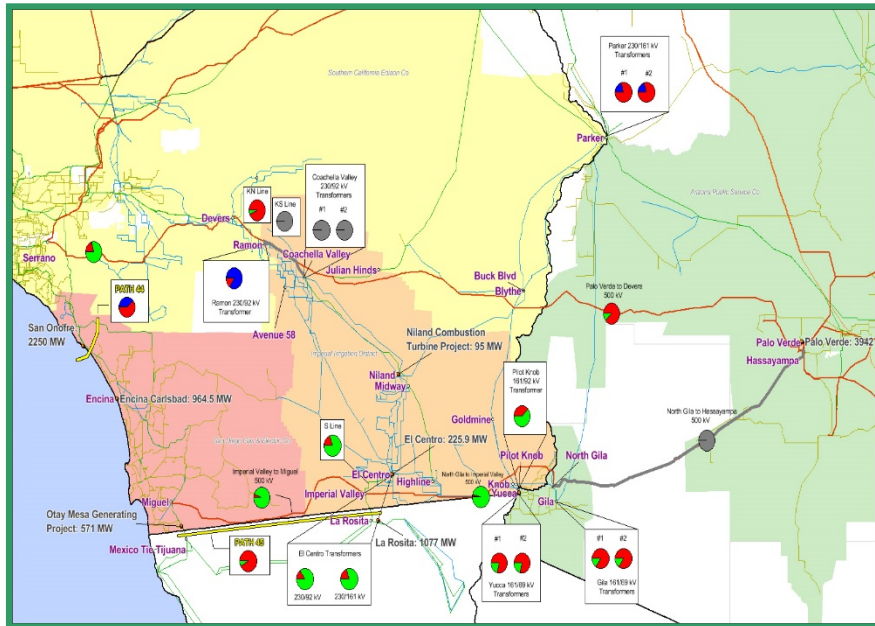
**15:28:17 – Two Coachella Valley 230/92 kV transformers and the Coachella Valley Ramon 230 kV “KS” line tripped. (030)**

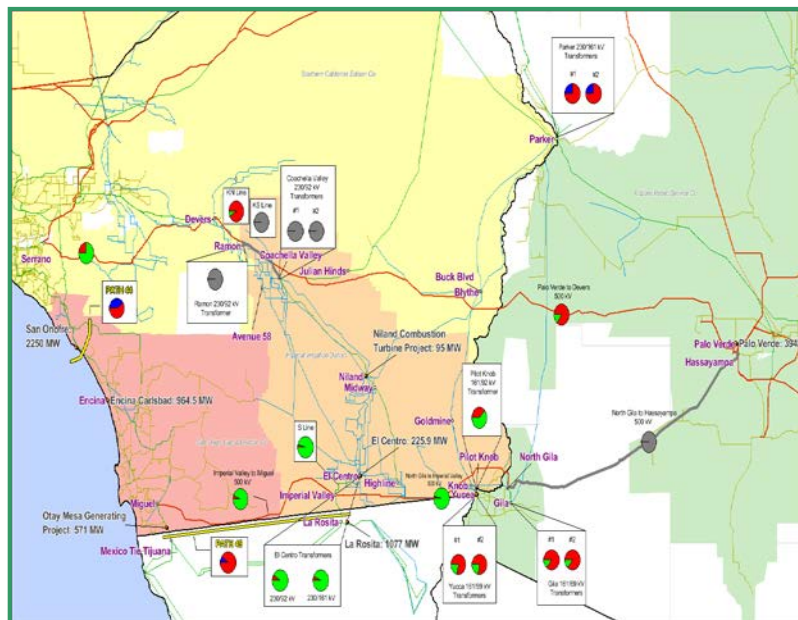
#### Time: 15:32:10 – The Ramon 230/92 kV transformer tripped and IID shed 444 MW of load. (110)

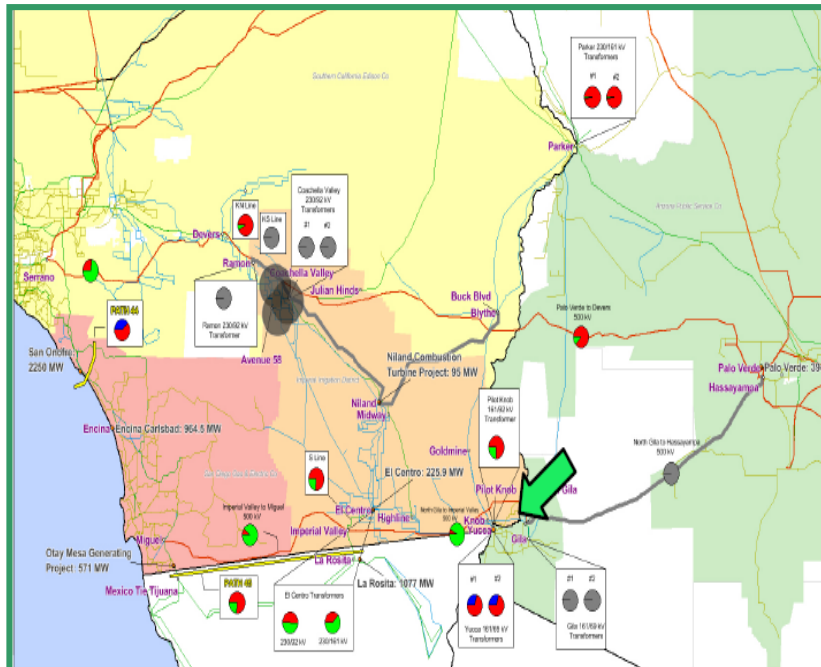
#### Time: 15:35:31 – Yuma Cogen (YCA) tripped. (180)

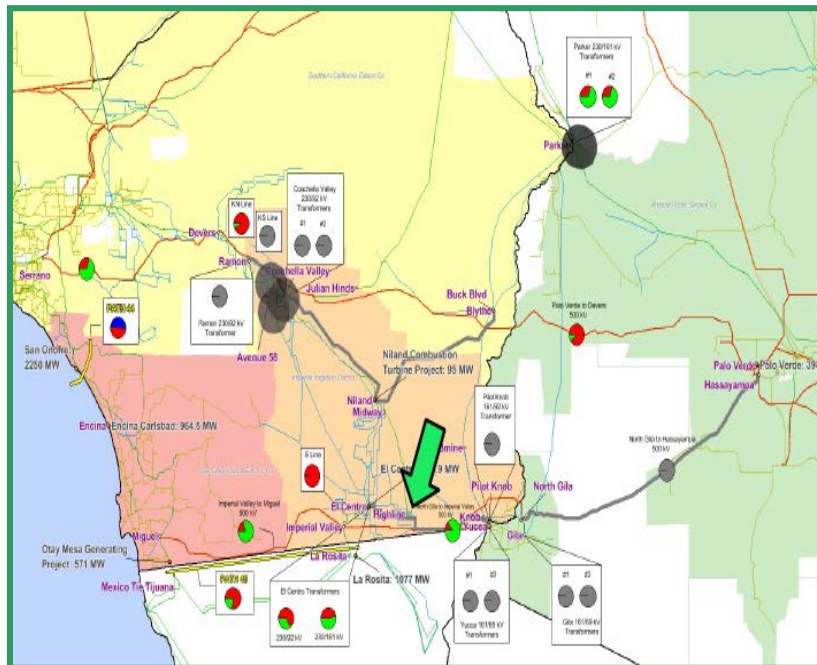
**Time: 15:37:55 – The El Centro-Pilot Knob 161 kV line tripped. (230)**

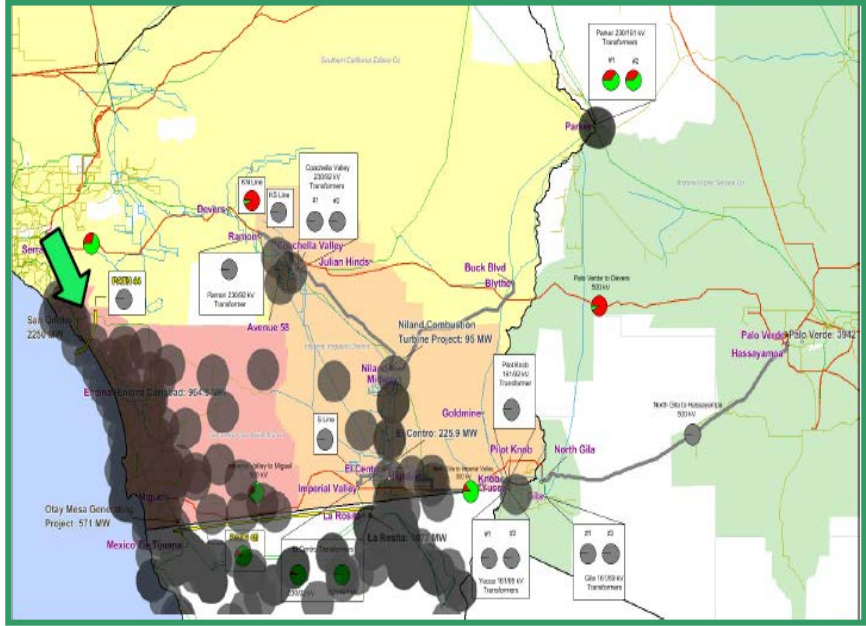
**Time: 15:38:30 – The South of SONGS Separation Scheme operates and both SONGS units tripped. (300)**

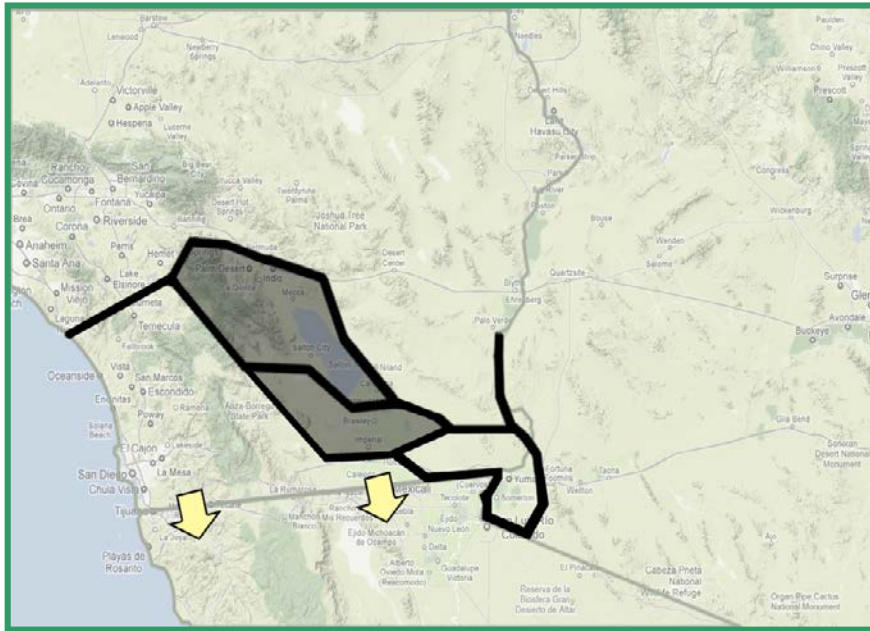
The Yuma island separated from SDG&E at 15:38:23.12, when the Imperial Valley-North Gila 500 kV transmission line tripped by underfrequency protection. APS's UFLS operated on 26 out of the 28 feeders in the Yuma area prior to the loss of the local Yucca steam generators that were on line. However, there was insufficient local generation to stabilize the load pocket in Yuma. At 15:38:38, the Yuma island internal units tripped on underfrequency protection.

**Yuma Separates (Time: 15.38.23.12)**

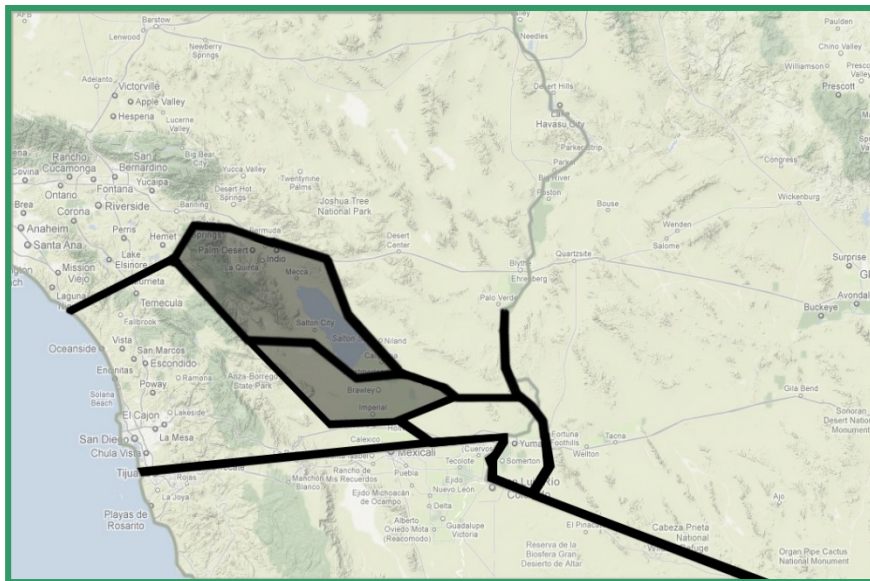
The CFE island separated from SDG&E after their only two remaining ties tripped in rapid succession. At 15:38:22.2, the Otay Mesa-Tijuana 230 kV transmission line open-ended at Tijuana in CFE's territory due to underfrequency protection.<sup>55</sup> Less than a second later, at 15:38:23.13, the Imperial Valley-La Rosita 230 kV transmission line open-ended at Imperial Valley in SDG&E's territory by underfrequency protection.<sup>56</sup> According to CFE, its UFLS program was not designed for the operation of a SDG&E/CFE/Yuma island, but for the operation of a "southern WECC island."

**CFE Separates (Time: 15.38.23.13)**

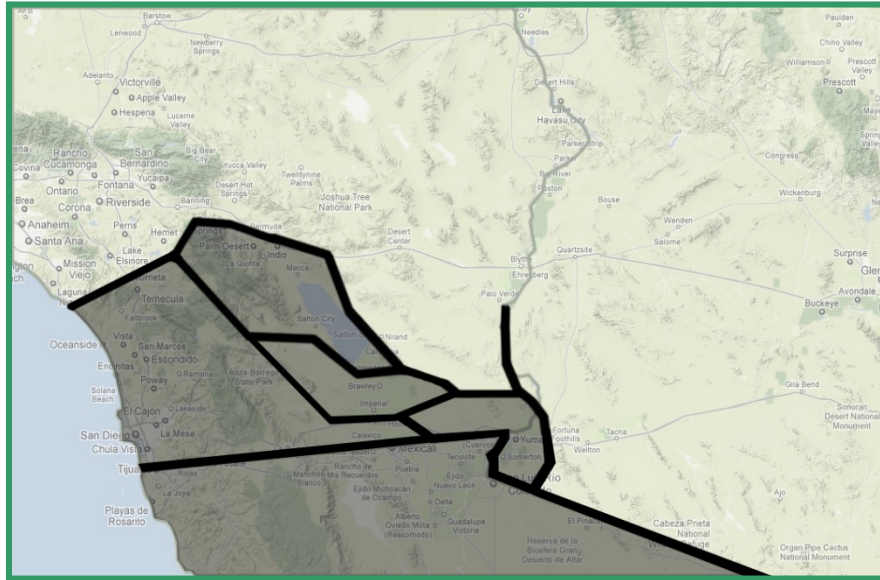
By 15:38:38, the SDG&E, CFE and Yuma islands had all collapsed, leaving approximately 2.7 million customers without power.

**SDG&E, CFE, and Yuma Blackout ( by 15.38.30)**

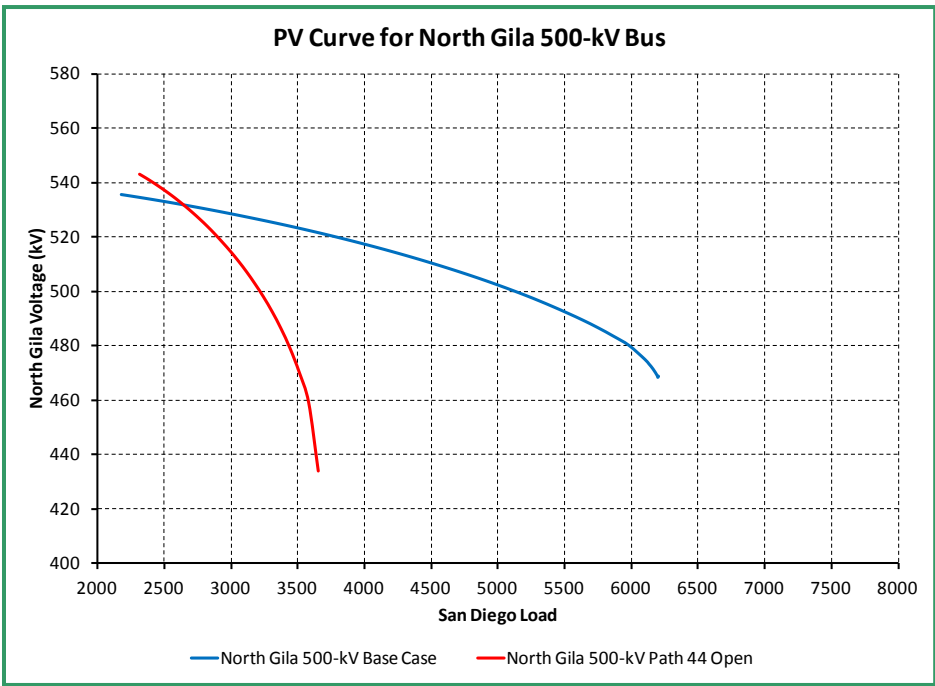
**Figure 16: PV Curve for North Gila 500 kV Bus**

Specifically, the system is most likely to collapse when the SDG&E load exceeds 3,500 MW. In 2010, SDG&E's load exceeded this amount for 851 hours,<sup>97</sup> meaning that the system was exposed to a potential blackout for approximately 10% of the year. This shows the potential risk to BPS reliability during normal system operations as a result of the inadvertent operation of the SONGS separation scheme. Accordingly, given the lack of studies done on the scheme, the inquiry recommends that the inadvertent operation of the SONGS separation scheme be reviewed promptly to ensure it does not pose an unacceptable risk to BPS reliability. Until this verification can be completed, CAISO and SCE should consider all actions needed to minimize this risk, up to and including temporarily removing the scheme from service.

Moreover, if SCE and CAISO were to decide to temporarily remove the scheme from the service, the inquiry does not believe that BPS reliability would be jeopardized. Indeed, inquiry simulations conducted for the day of the event show that if the scheme had not operated, the system, with the exception of collapses in the IID and Yuma areas, would have stabilized with minor overloads in the area around SONGS, acceptable voltages in the SDG&E area, and sufficient reactive margins in the critical portion of SCE's system.

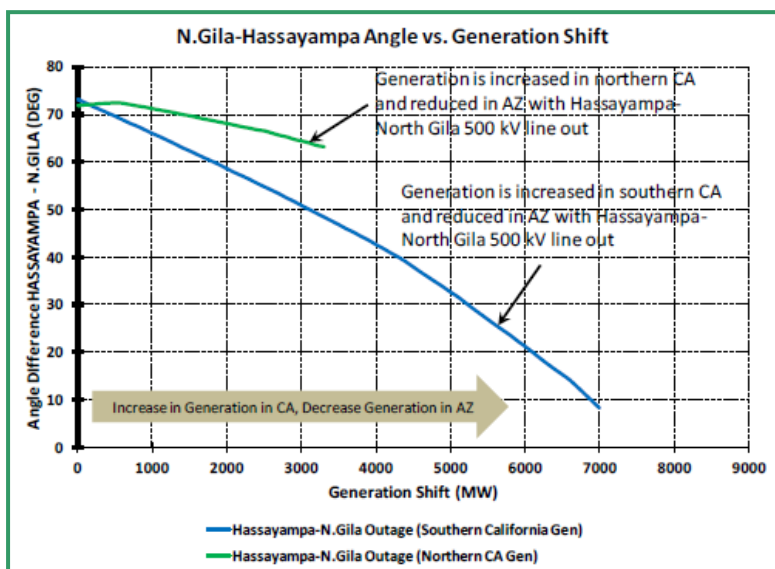
**Figure 17: Phase Angle of H-NG vs. Generation Shift**

The blue line in Figure 17 illustrates that with the particular conditions of the September 8th event, approximately 1,800 MW needed to be redispatched on both ends of H-NG (and close to the terminals, in Southern California and Arizona) in order to close the voltage phase angle from 72 degrees to 60 degrees (i.e., to within the permissive 60 degree setting of the synchro-check relay). The green line shows that more generation—more than twice as much—must be redispatched if units are chosen in Northern California to close the angle between Hassayampa and North Gila.

While system operators could redispatch generation from available spinning reserves or commit units in the Southern and/or Northern California area, it is questionable how quickly 1,800 MW could be dispatched.
