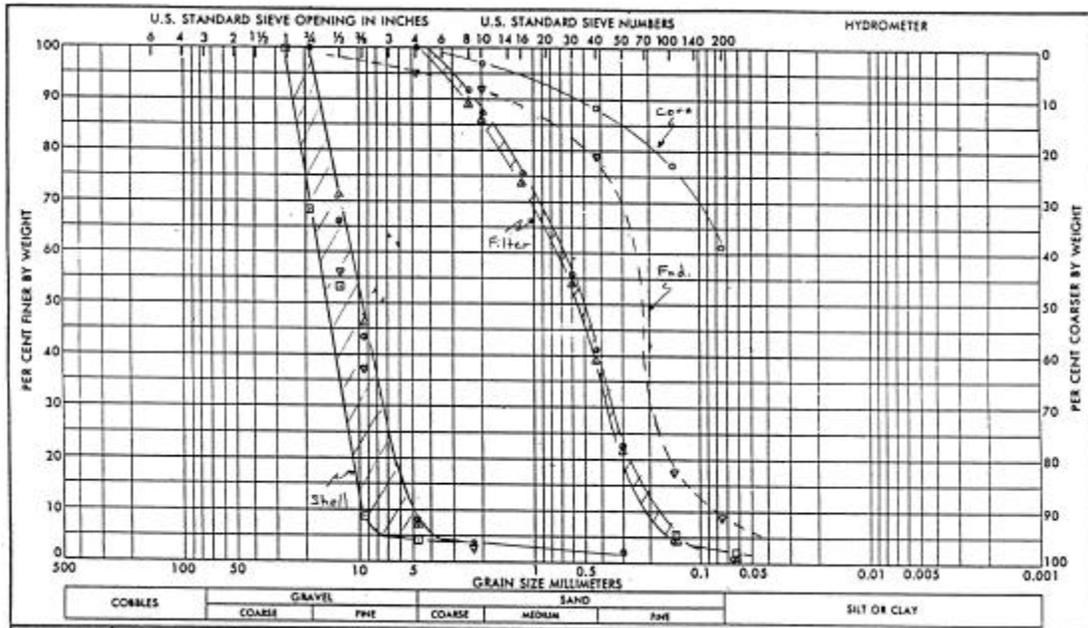
Figure 1, Gradation Curves

The foundation observed in the side walls of the breach includes a stratum of tan loose to medium dense sand from the ground surface to an approximate depth of 8-10 feet. This stratum contains some outwash material, but is primarily weathered till. The repeated freezing and thawing, with the resultant volume increase of in-situ water, is primarily responsible for creating the loose structure from the original dense till. Beneath the surface layer is a zone of tan very dense weathered till approximately 10 feet thick, followed by dark gray very dense unweathered till to great depth. Both of these stratum appeared cemented. The grain size distribution of all till layers appeared to be a slightly silty coarse to fine sand with some gravel, with the most noticeable difference in stratums being the tan coloration of the upper two weathered zones, and the looser density of the uppermost zone. The till was in general void of clayey or plastic fines. When samples of either the dense tan weathered or gray unweathered till were placed in water, they quickly “melted” into a cohesionless mass. During construction, one grain size analysis was performed on material identified as "foundation soil," sample S-10 in the MWH final construction report. This gradation curve is shown on Figure 1.

c) Fuse Plug. The gradation of four zone 2 filter samples, four zone 3 shell samples, and one core sample are also shown on Figure 1. Being processed materials, the filter and shells have relatively narrow gradation bounds, and filter D15/D85 criteria are met as long as segregation does not occur. These criteria are also satisfied between the core/foundation and placed filter. The forthcoming investigation report by STS should include additional gradation curves for the foundation samples, taken from the small island (original graded channel) that remained after the breach.

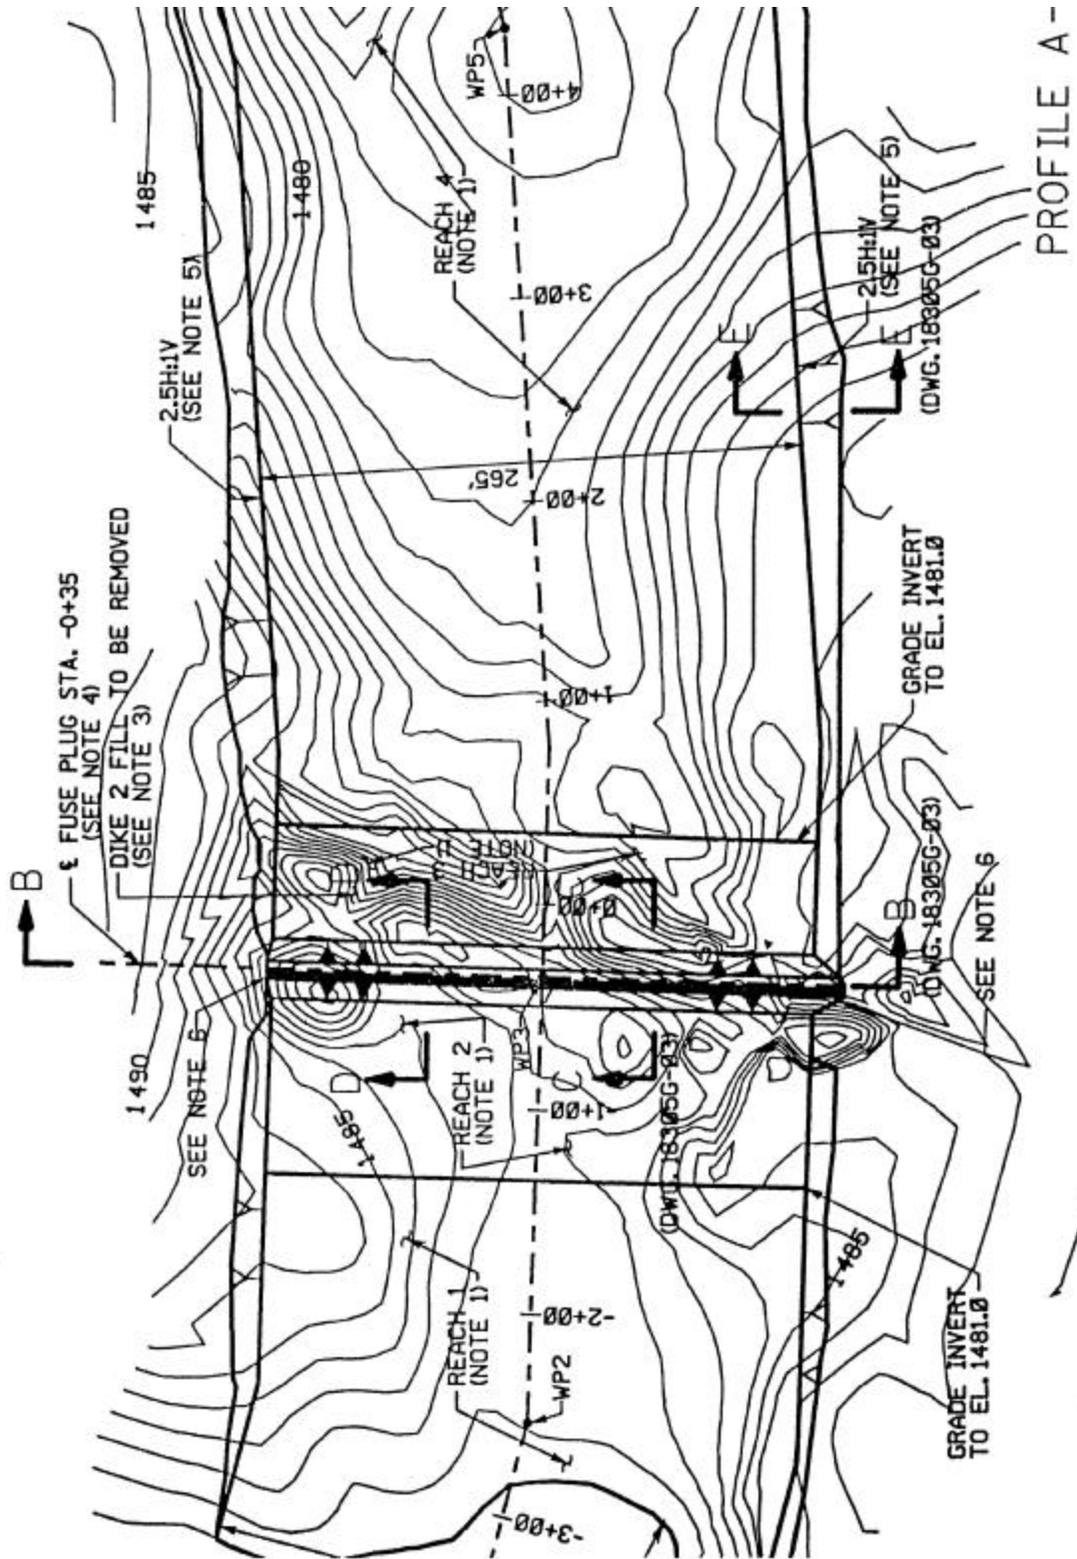
Figure 2, Preconstruction Topography

The original topography shown on the MWH 20895-C5 drawing includes several interesting dike and foundation features, as shown in enlargement on Figure 2. The original dike 2 crest was skewed compared to the constructed fuse plug, and appears to contain two low points in the crest; one at elevation 1484 near the dike centerline, and one at elevation 1486 near the western abutment. These features, if real, would have allowed minor overtopping flows during high water periods in previous years. The topography downstream of dike 2 also suggests small flows and erosion could have been occurring in the past.

Of greater interest to the fuse plug construction are the pits shown upstream of dike 2, in particular the pit near the east abutment. These are drag-line pits and were the borrow source for the original dike construction during the 8-foot-high dam rising in the 1940's. These drag-line pits are shown in photos from operation reports prior to fuse plug construction, and remain visible today at the other dike locations. The large drag-line pit, with bottom elevation 1478, was subsequently overlain by the new fuse plug alignment. It is likely that the 1478 elevation shown includes several feet of muck or washed in soil, and the original pit would have been deeper. The implications of performing muck removal and compaction with backfill having a permeability comparable to the remainder of the foundation are significant, and could represent a foundation weakness for seepage and piping if not properly addressed. Interviews with construction personnel, which have not occurred to date, should address this issue.

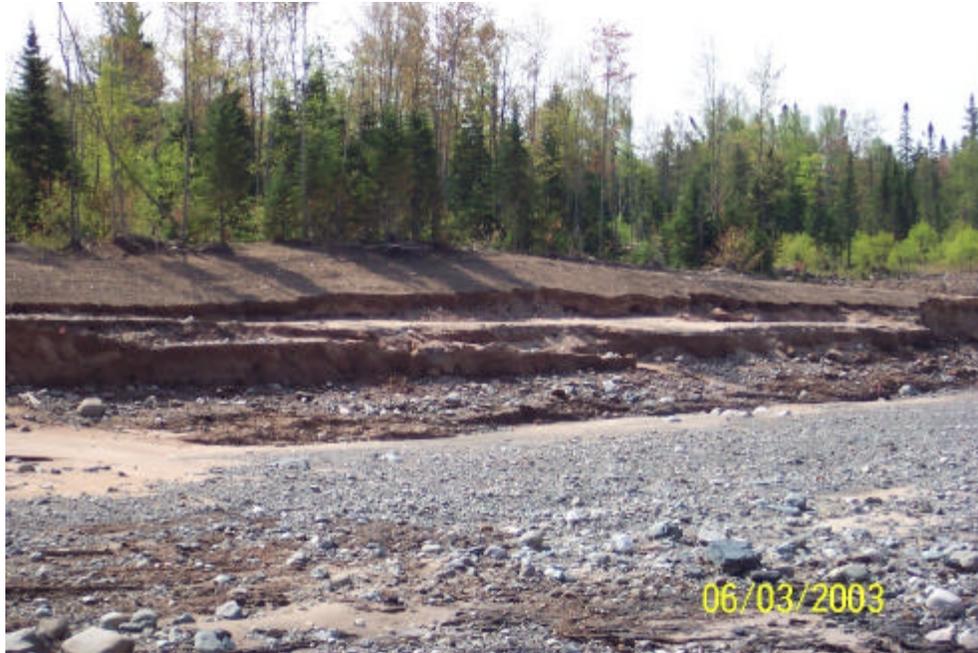
Hydraulic failures involving earth structures typically remove the forensic evidence needed to reconstruct the failure. One aspect is known, i.e., it is conclusive that the final phase of the breach involved channel floor cutting on the right side of the channel, due either to the shorter hydraulic distance of the curving channel or slightly more erodible soils. However, the Silver Lake breach channel may provide other evidence to allow speculation on the sequence of events. The modest left bank erosion along the original channel slope, shown in Photograph 1, indicates moderate flow in this area prior to the major breach and erosion along the right side of the channel. This may indicate that the problem originated near the left abutment. If this interpretation is correct, the previous discussion regarding construction over the left abutment drag-line pit has added credence.

Photo 1. Left bank erosion with remnants of original slope. Upper bench and slope erosion indicates level of initial flow

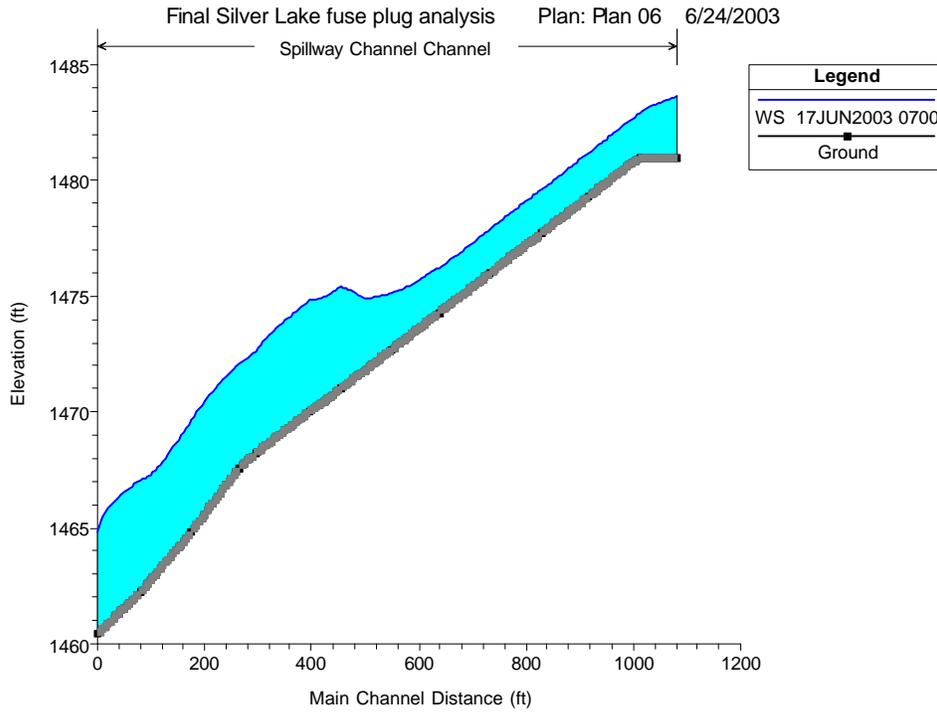
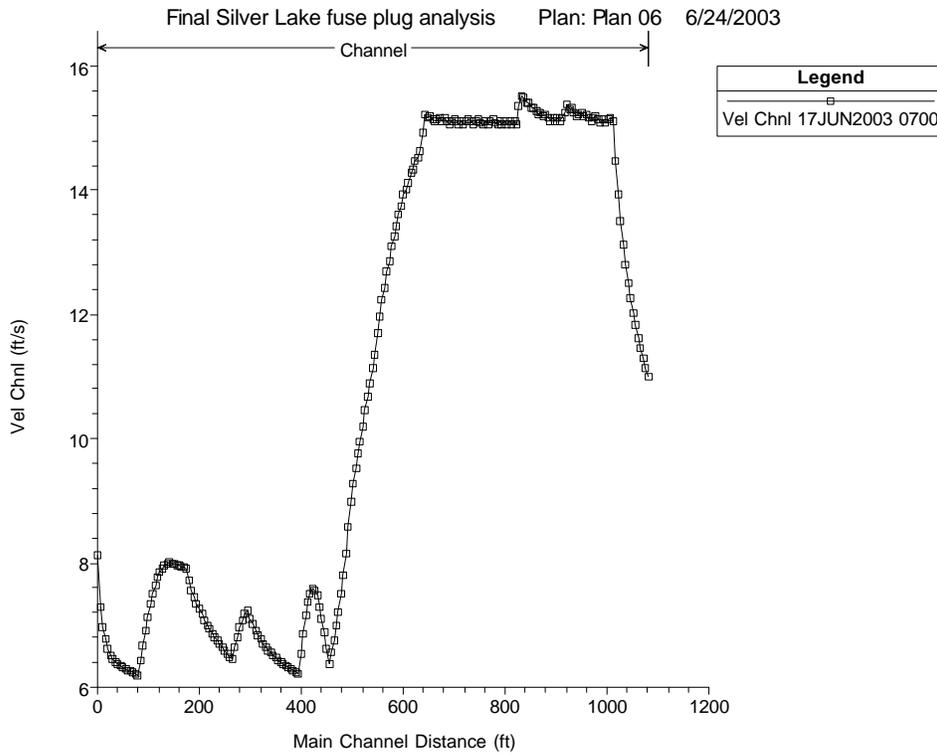
Similar analyses were conducted for peak flows during the breach at the reservoir high water mark of 1485.6, assuming the channel floor did not erode, as shown in Figures 3 and 4. Figure 3 models the earth channel without grass, which was the existing condition during the breach. Calculated velocities over 15 fps occur for much of the exit channel. If the grass had been established, the calculated velocities would have been around 10 fps, as shown in Figure 4. With or without grass, it appears the channel floor was susceptible to erosion.

MAX. WATER SURFACE ELEVATION – Flow: 7,750 cfs
Uniform channel section $n=0.02$

MAX. CHANNEL VELOCITIES – Flow: 7,750 cfs
Uniform channel section $n=0.02$

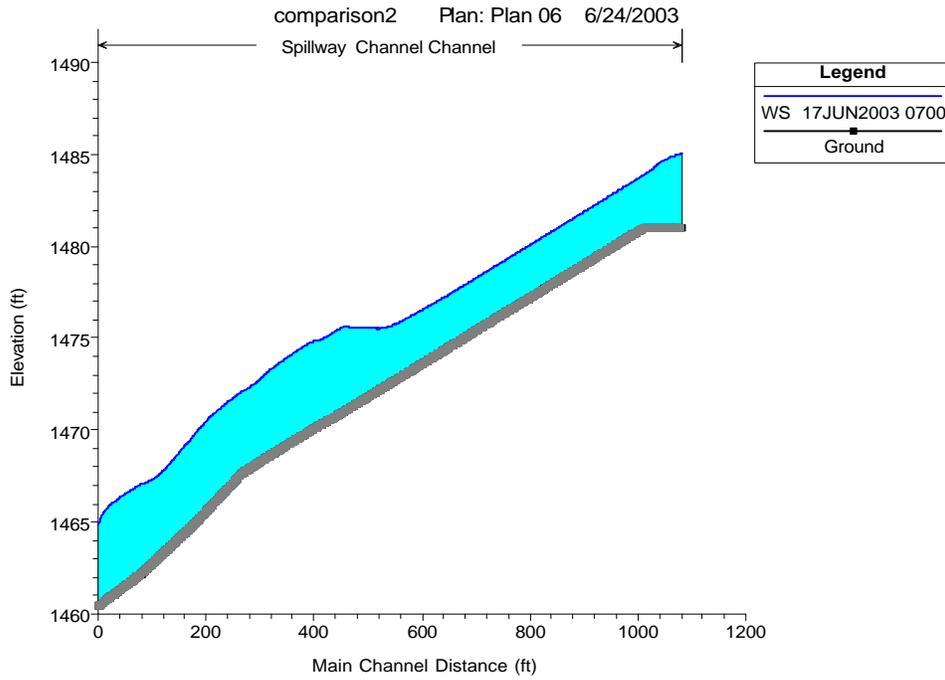
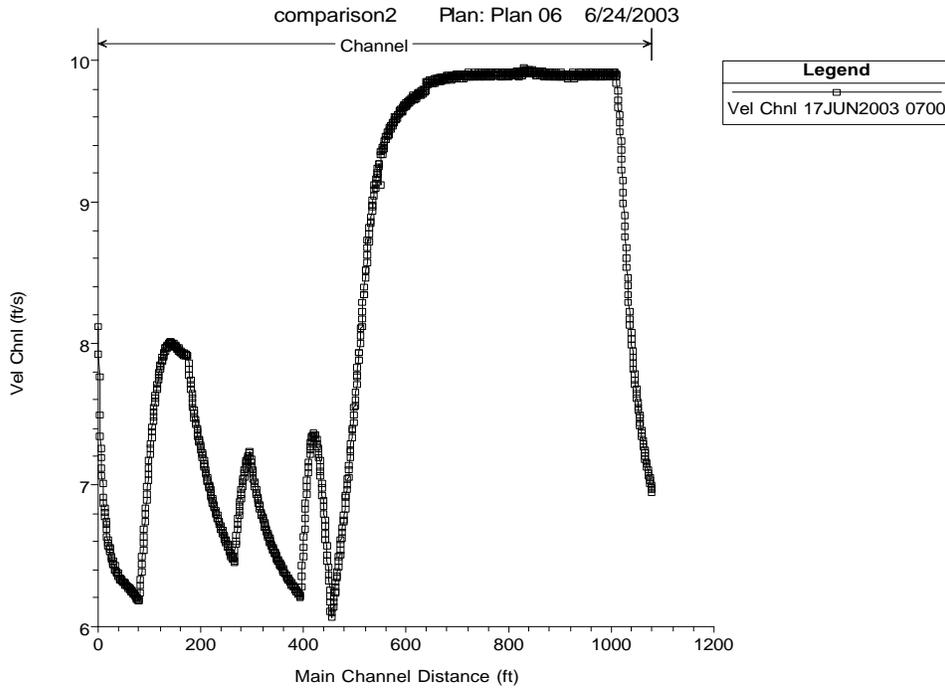
Figure 4

MAX. WATER SURFACE ELEVATION – Flow: 7,750 cfs
Revised model with uniform channel section n=0.04

MAX. CHANNEL VELOCITIES – Flow: 7,750 cfs
Revised model with uniform channel section n=0.04
