5. How and Why the Blackout Began in Ohio

Summary

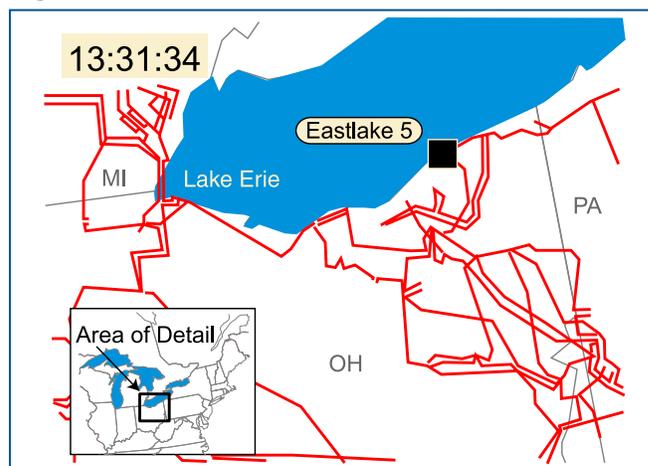
Figure 5.3. Eastlake Unit 5

When Eastlake 5 dropped off-line, replacement power transfers and the associated reactive power to support the imports to the local area contributed to the additional line loadings in the region. At 15:00 EDT on August 14, FE's load was approximately 12,080 MW, and they were importing about 2,575 MW, 21% of their total. FE's system reactive power needs rose further.

The investigation team's system simulations indicate that the loss of Eastlake 5 was a critical step in the sequence of events. Contingency analysis simulation of the conditions following the loss of the Harding-Chamberlin 345-kV circuit at 15:05 EDT showed that the system would be unable to sustain some contingencies without line overloads above emergency ratings. However, when Eastlake 5 was modeled as in service and fully available in those simulations, all overloads above emergency limits were eliminated, even with the loss of Harding-Chamberlin.

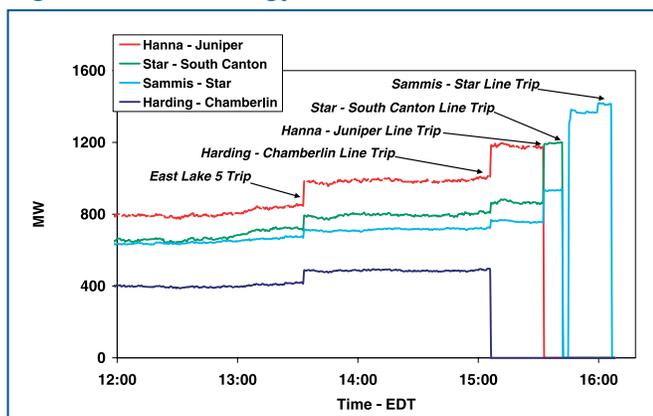
Figure 5.5. FirstEnergy 345-kV Line Flows

A short-circuit occurred on the Harding-Chamberlin 345-kV line due to a contact between the line conductor and a tree. This line failed with power flow at only 44% of its normal and emergency line rating. Incremental line current and temperature increases, escalated by the loss of Harding-Chamberlin, caused more sag on the Hanna-Juniper line, which contacted a tree and failed with power flow at 88% of its normal and emergency line rating. Star-South Canton

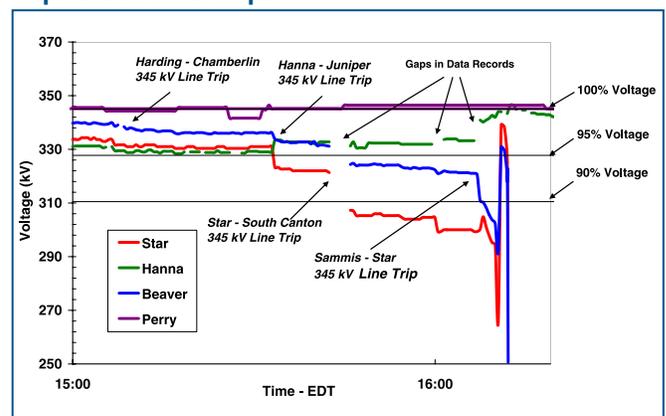
Figure 5.6. Voltages on FirstEnergy's 345-kV Lines: Impacts of Line Trips

From 15:05:41 EDT to 15:41:35 EDT, three 345-kV lines failed with power flows at or below each transmission line's emergency rating. These line trips were not random. Rather, each was the result of a contact between a line and a tree that had grown so tall that, over a period of years, it encroached into the required clearance height for the line. As each line failed, its outage increased the loading on the remaining lines (Figure 5.5). As each of the transmission lines failed, and power flows shifted to other transmission paths, voltages on the rest of FE's system degraded further (Figure 5.6).

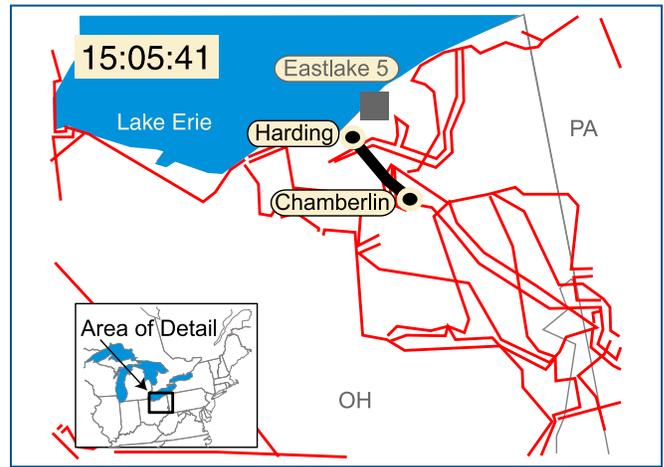
Figure 5.8. Harding-Chamberlin 345-kV Line

Harding-Chamberlin was not one of the flowgates that MISO monitored as a key transmission location, so the reliability coordinator was unaware when FE’s first 345-kV line failed. Although MISO received

SCADA input of the line’s status change, this was presented to MISO operators as breaker status changes rather than a line failure. Because their EMS system topology processor had not yet been linked to recognize line failures, it did not connect the breaker information to the loss of a transmission line. Thus, MISO’s operators did not recognize the Harding-Chamberlin trip as a significant contingency event and could not advise FE regarding the event or its consequences. Further, without its state estimator and associated contingency analyses, MISO was unable to identify potential overloads that would occur due to various line or equipment outages. Accordingly, when the Harding-Chamberlin 345-kV line tripped at 15:05 EDT, the state estimator did not produce results and could not predict an overload if the Hanna-Juniper 345-kV line were to fail.

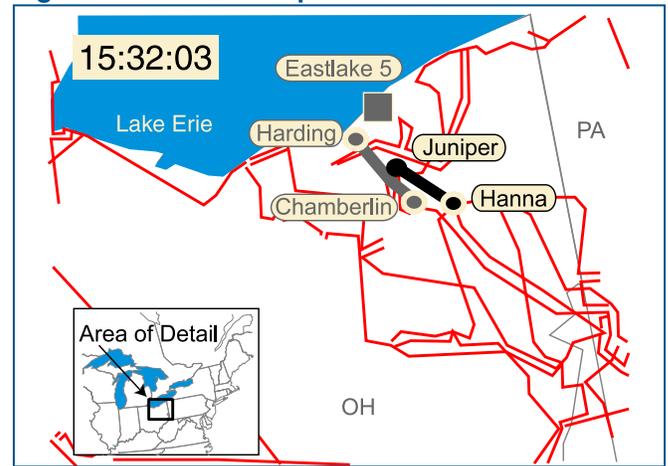
Figure 5.9. Hanna-Juniper 345-kV Line

Hanna-Juniper was loaded at 88% of its normal and emergency rating when it tripped. With this line open, over 1,200 MVA of power flow had to find a new path to reach its load in Cleveland. Loading on the remaining two 345-kV lines increased, with Star-Juniper taking the bulk of the power. This caused Star-South Canton's loading to rise above its normal but within its emergency rating and pushed more power onto the 138-kV system. Flows west into Michigan decreased slightly and voltages declined somewhat in the Cleveland area.

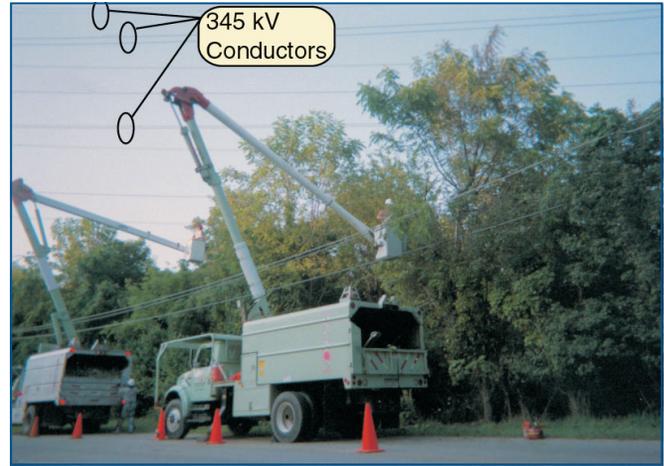
Figure 5.10. Cause of the Hanna-Juniper Line Loss

This August 14 photo shows the tree that caused the loss of the Hanna-Juniper line (tallest tree in photo). Other 345-kV conductors and shield wires can be seen in the background. Photo by Nelson Tree.

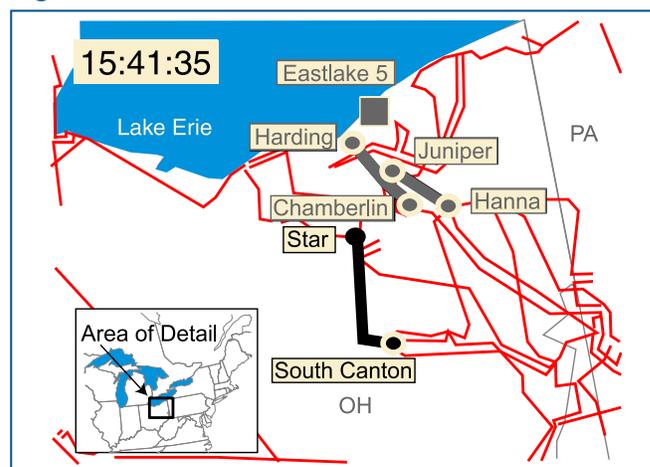
Figure 5.11. Star-South Canton 345-kV Line

contacted a tree three times between 14:27:15 EDT and 15:41:33 EDT, opening and reclosing each time before finally locking out while loaded at 93% of its emergency rating at 15:41:35 EDT. Each of these three lines tripped not because of excessive sag due to overloading or high conductor temperature, but because it hit an overgrown, untrimmed tree.²²

The investigation’s field team inspected the right of way in the location indicated by the relay digital fault recorders, in the FE portion of the line. They found debris from trees and vegetation that had been felled. At this location the conductor height was 44 feet 9 inches (13.6 meters). The identifiable tree remains measured 30 feet (9.1 meters) in height, although the team could not verify the location of the stump, nor find all sections of the tree. A nearby cluster of trees showed significant fault damage, including charred limbs and de-barking from fault current. Further, topsoil in

the area of the tree trunk was disturbed, discolored and broken up, a common indication of a higher magnitude fault or multiple faults. Analysis of another stump showed that a fourteen year-old tree had recently been removed from the middle of the right-of-way.²⁸

Recommendations
16, page 154; 27, page 162

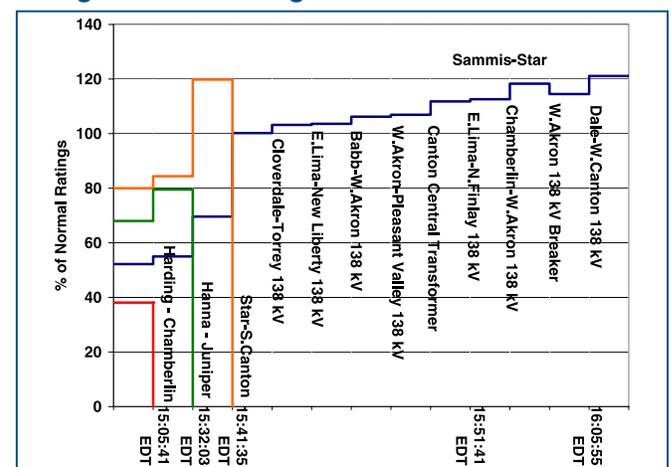
Figure 5.12. Cumulative Effects of Sequential Outages on Remaining 345-kV Lines

- ◆ The Star-Juniper 345-kV line, whose loadings would exceed emergency limits if the Hanna-Juniper 345-kV line were lost; and

- ◆ The Hanna-Juniper and Harding-Juniper 345-kV lines, whose loadings would exceed emergency limits if the Perry generation unit (1,255 MW) were lost.

Operationally, once FE’s system entered an N-1 contingency violation state, any facility loss beyond that pushed them farther into violation and into a more unreliable state. After loss of the Harding-Chamberlin line, to avoid violating NERC criteria, FE needed to reduce loading on these three lines within 30 minutes such that no single contingency would violate an emergency limit; that is, to restore the system to a reliable operating mode.

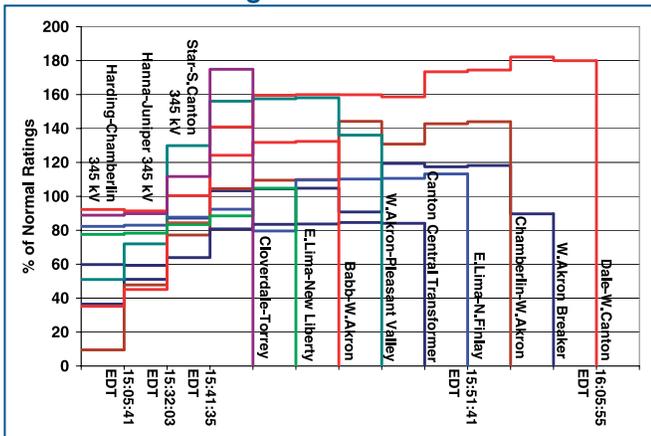
Figure 5.15. Simulated Effect of Prior Outages on 138-kV Line Loadings

The investigation team examined whether load shedding before the loss of the Sammis-Star 345-kV line at 16:05:57 EDT could have prevented this line loss. The team found that 1,500 MW of load would have had to be

dropped within the Cleveland-Akron area to restore voltage at the Star bus from 90.8% (at 120% of normal and emergency ampere rating) up to 95.9% (at 101% of normal and emergency ampere rating).⁴⁴ The P-V and V-Q analysis reviewed in Chapter 4 indicated that 95% is the minimum operating voltage appropriate for 345-kV buses in the Cleveland-Akron area. The investigation team concluded that since the Sammis-Star 345 kV outage was the critical event leading to widespread cascading in Ohio and beyond, if manual or automatic load-shedding of 1,500 MW had occurred within the Cleveland-Akron area before that outage, the blackout could have been averted.

Recommendations
8, page 147; 21, page 158; 23, page 160
