**FERC Engineering Guidelines
Risk-Informed Decision Making**

Chapter R5

**Concrete Dam Analysis
Arch, Gravity and Buttress Dams**

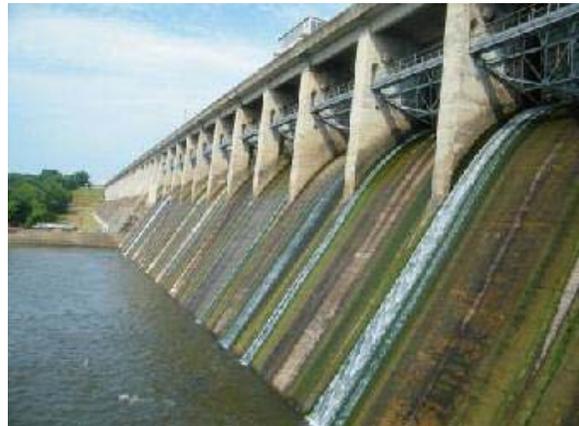
Gravity Dam

1) **Gravity Dams:** Dams that resist the reservoir loading by frictional resistance with their foundations. Concrete stresses tend to be low. Extreme overtopping of these dams is typically the greatest threat to stability because of higher reservoir driving forces and increased uplift pressures on the dam base.

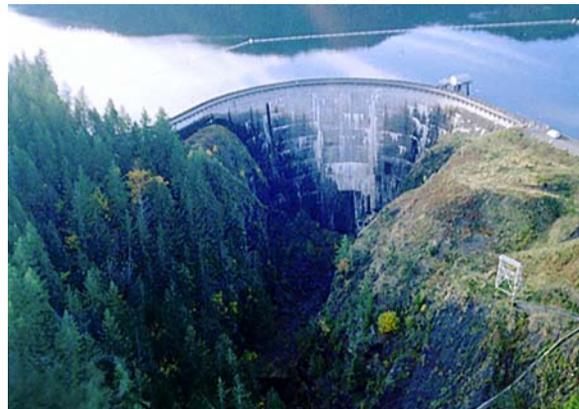
Arch Dam

2) **Arch dams:** These Dams transfer load to abutments. The strength of the abutment rock is critical to their stability. Stresses in these dams tend to be moderate. Overtopping can be an issue for arch dams if erosion of the abutment rock results.

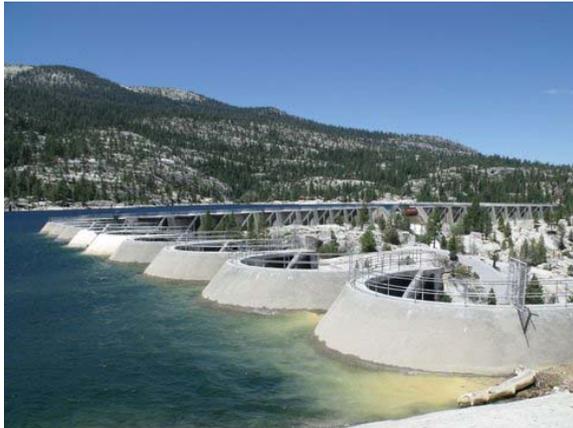
Buttress Arch Dam

These dams have a series of relatively thin slabs or arches which slope upward going downstream. Typically the angle of slope is about 45° . This slope causes the reservoir to produce a downward force approximately equal to the downstream driving force, stabilizing the dam. The slabs or arches are supported by a series of buttresses. Stresses can be high in these dams. They are susceptible to earthquake induced failure, especially from ground motions in the cross valley direction. They are also susceptible to local foundation weakness because all it takes is for one buttress to be poorly founded for failure to result. Freeze thaw damage often causes deterioration of concrete if the dam is in a cold weather environment.

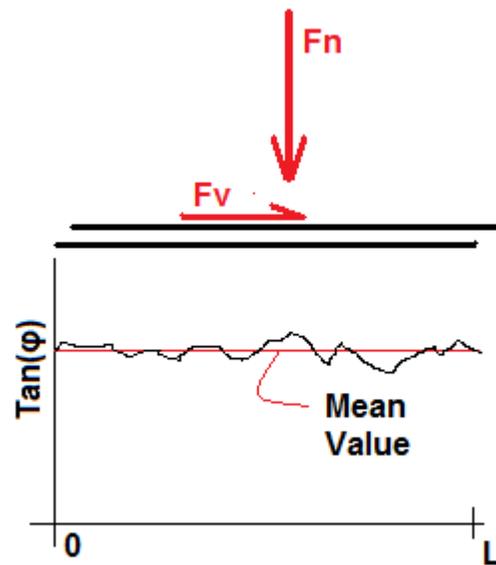
Consider for example the case depicted in Fig. R5.3.1 below in which the failure mode of frictional sliding is being considered. There will always be some random variation of the coefficient of friction, and what has historically been done is to downgrade $Tan(\phi)$ to account for this variation, insuring that the shear resistance of the failure plane is at least as great as what is calculated. This technique will necessarily under estimate the strength of the failure plane and result in an overestimate of failure probability.

Integrating the shear resistance over the failure plane results in F_n times the mean value of $Tan(\phi)$. This phenomenon occurs because the failure mode being considered is a parallel failure mode, one in which weaker shear strengths are offset by stronger ones. In such cases, the variation of the parameter becomes irrelevant and the total system strength is contingent upon the mean value only.

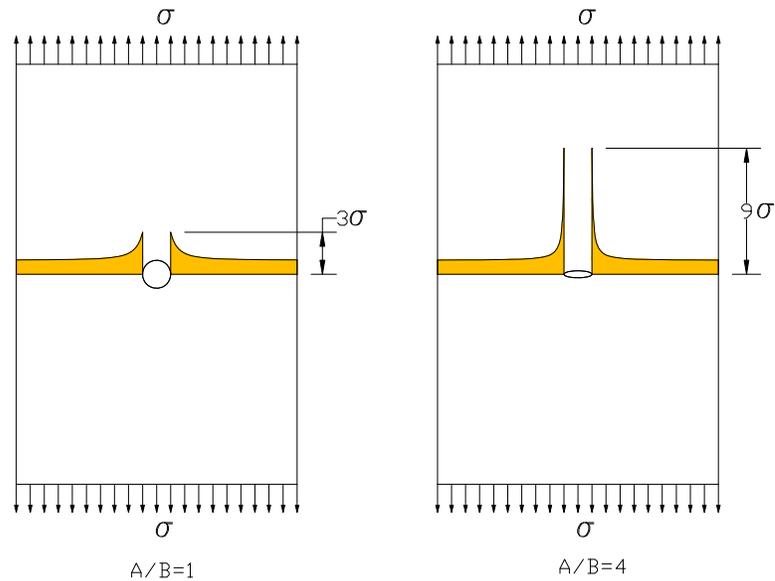
Fig. R5.3.2

The closed form solution for an elliptical hole in an elastic plate subject to uniaxial tension is helpful in understanding the stress at a crack tip. (See Fig R5.3.2). The increase in stress at the perimeter of the hole is given by:

Where A is the ellipse axis perpendicular to the stress field and B is the ellipse axis parallel to the stress field.

As can be seen, as the A/B ratio becomes large, the ellipse begins to resemble a crack. At large A/B ratios, the stress amplification becomes enormous. In elasto plastic materials such as mild steel, a zone of plasticity forms around the crack tip and the crack propagates only with difficulty. In brittle materials however, the crack propagates. If the tension field is kept constant, crack propagation progresses at sonic velocities. Because the stress amplification at the crack tip is so great, the crack can continue to propagate through areas where the tension field is significantly less than the tension required to initiate cracking. The crack will propagate not only to where the tension field is less than the tensile strength of the concrete, but it will continue until it gets to a region of no tension. For this reason, once a crack begins to propagate, the tensile strength of concrete becomes irrelevant.

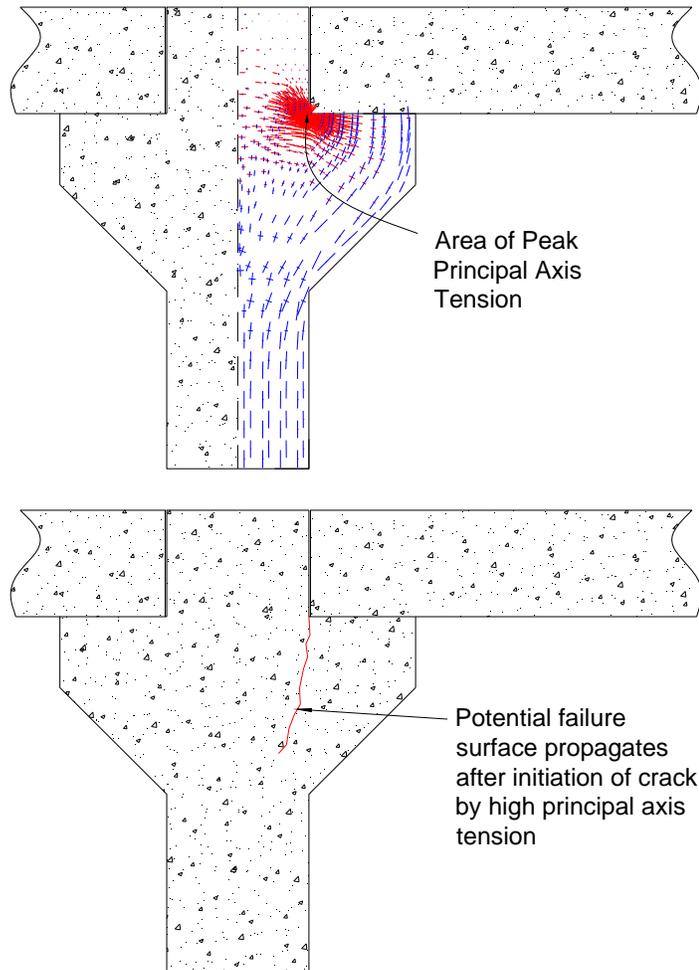
Fig. R5.3.3

Now consider the case depicted in Fig. R5.1.3.3. Here the failure mechanism is shear failure of an unreinforced or under reinforced corbel supporting the upstream slab of a slab and buttress dam. Note that the upstream corner of the corbel is highly stressed in tension. If tension exceeds the concrete strength, a crack will initiate and begin to propagate in a path approximately perpendicular to the axis of principal tension. While this is considered a shear failure mechanism, the controlling parameter will be tensile strength.

Unlike the parallel failure mode described in R5.3.1, there is no way for weak areas to transfer load to stronger areas. This is a series failure mode. What controls the failure mechanism is the weakest link, not the average strength. If tensile strength variation allows for the possibility of the concrete tensile strength to be exceeded, the probability of failure can become very high.

Suppose now that the failure mechanism is series. For example, consider the corbel shear example in R5.3.3. Suppose further that you have no tensile test data, and only the design records that state that the specified concrete strength was 4000 psi. Assuming that the concrete was mixed to insure that the 4000 psi was equaled or exceeded, and that no test fell below 3500 psi, (ACI 318 requirements), it is reasonable to assume that the mean compressive strength at 28 days was 4700 psi with a standard deviation 500 psi. The probability density function (PDF) based on these assumptions is shown below (Fig R5.3.5).

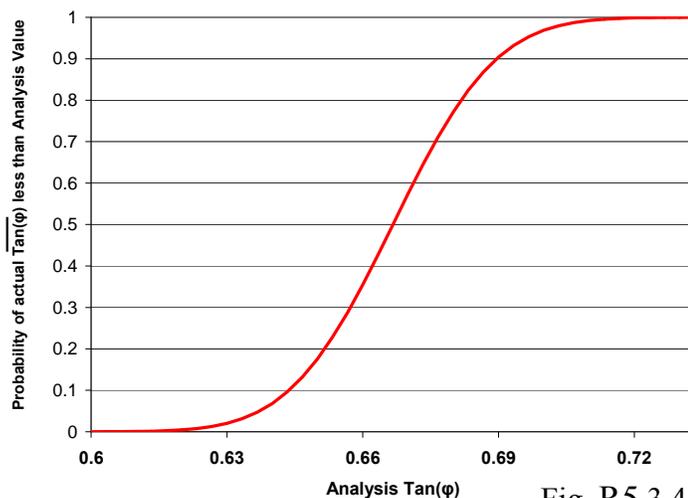
Fig. R5.3.4

The PDF for the sample mean is then a normal distribution with a mean of .667 and a standard deviation of .0179. The probability that the real mean is

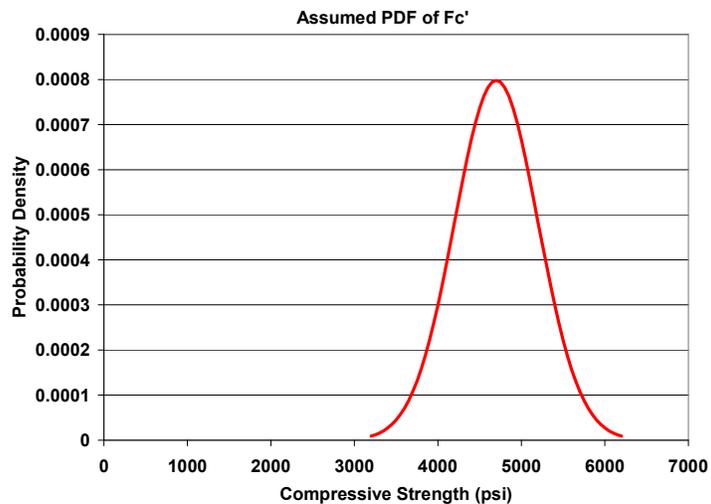
Fig. R5.3.5

In our case, the PDF of f_c' is, $n(4700,500)$. Our G function is the inverse of the Raphael equation:

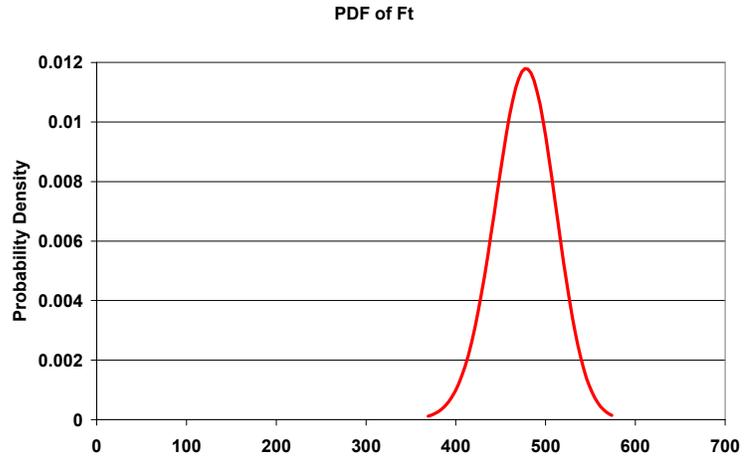
Fig. R51.3.6

This PDF is now no longer normal in f_t . It is depicted in Fig R5.3.6. The mean of this PDF is 475 psi.

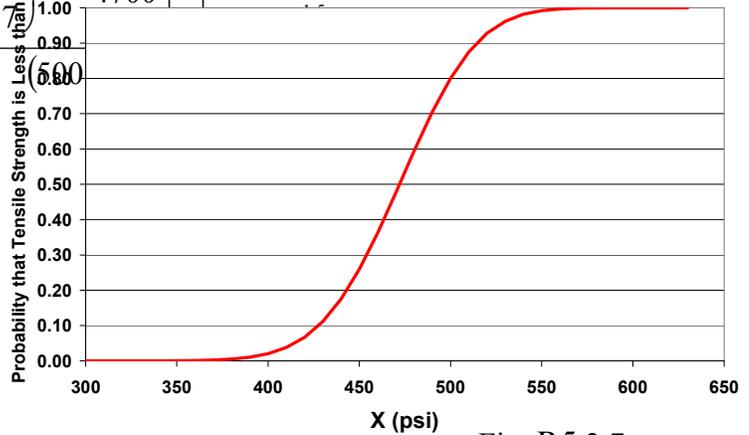
Fig. R5.3.7

Now the probability of corbel failure must be estimated. The probability that lift 1 has a tensile strength of less than the 425 psi shown in figure R5.3.8 can be read off Figure R5.3.7.

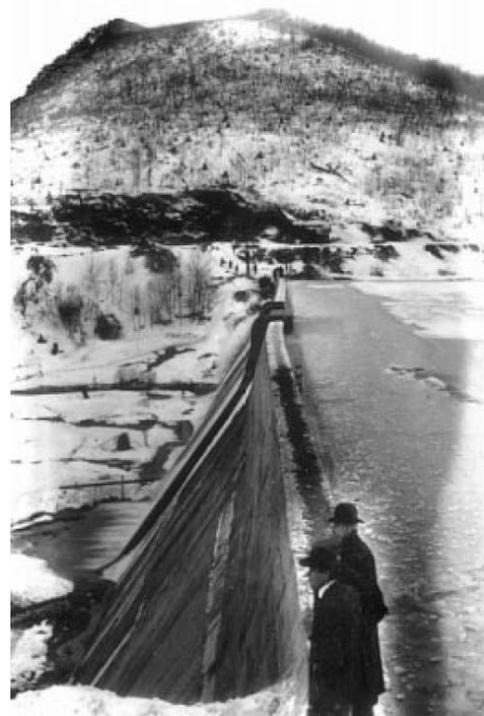
On January 17, 1910, a combination of heavy rain and snowmelt due to warm temperatures caused the reservoir to sharply raise and flow over the spillway. An undetermined thickness of ice still covered the reservoir. Heavy seepage near the toe of the dam with water bubbling up from the ground as far as 50 feet downstream and cracks on the downstream face of the dam were observed. The dam developed six prominent vertical cracks. The dam had been built without construction joints, so the cracks divided the dam into seven separate segments. A portion of the eastern earthen embankment slid down eight feet, allowing water to bypass the dam. To prevent a catastrophe, Bayless used dynamite to blast two notches in the

dam crest to lower the reservoir. The blasting had been necessary because the dam had no spillway gates to allow controlled water release (Greene and Christ 1998, p. 9). The combination of these efforts emptied the reservoir in around sixteen hours and major devastation was circumvented. The massive structure was pushed downstream an amazing 18 inches at its base and 31 inches at its crest. Superficial repairs were made to the dam after the water level dropped, and then the water level was allowed to rise to normal pool again despite leakage under the dam of about 600 gallons per minute (Freiman and Schlager 1995b, p. 208).

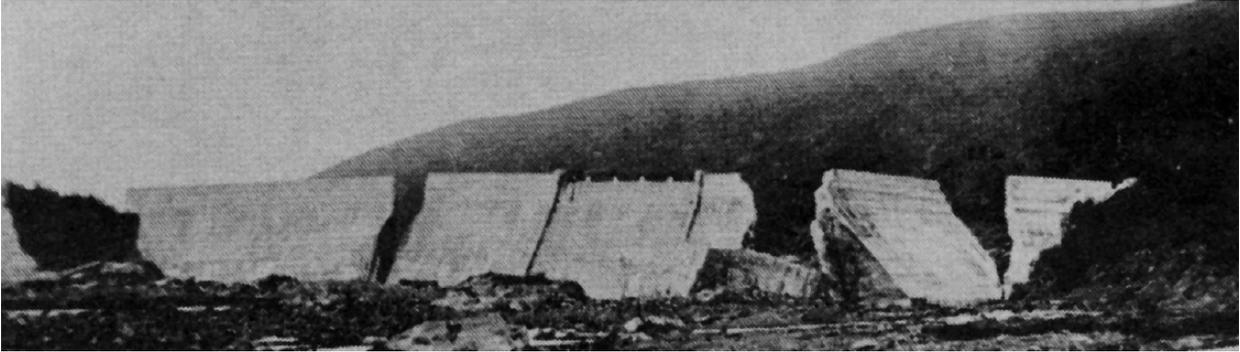
Rainfall in September 1911 was unusually heavy. Water began flowing over the spillway for the first time in about 20 months. The dam failed on the afternoon of Saturday, September 30, 1911. Post-failure analysis clearly showed that the plane of sliding developed in the shale underlying the sandstone, which represented the weakest zone in the foundation (Greene, 1997). In essence, the upper sandstone layer slid downstream along with the concrete blocks comprising the dam. This was a classic foundation failure in which the dam failed by sliding.

Back analysis suggests that sliding occurred on a weak shale layer within the foundation (Anderson et al, 1998). A friction angle of 48 degrees was required to prevent sliding if there is no cracking at the heel. Limit equilibrium analysis with reservoir at the crest of the dam and full uplift compute 26 lb/in² vertical tension at the heel with the resultant force well outside the kern of the base and almost to the toe of the dam. As a result, reservoir water could enter an upstream crack. Taking this into account, cracked-base analysis indicates cracks would extend through the dam to the toe. Using an estimated actual friction angle of probably between 25 and 31 degrees produces a sliding factor of safety less than 1.0.

Failed Austin Dam

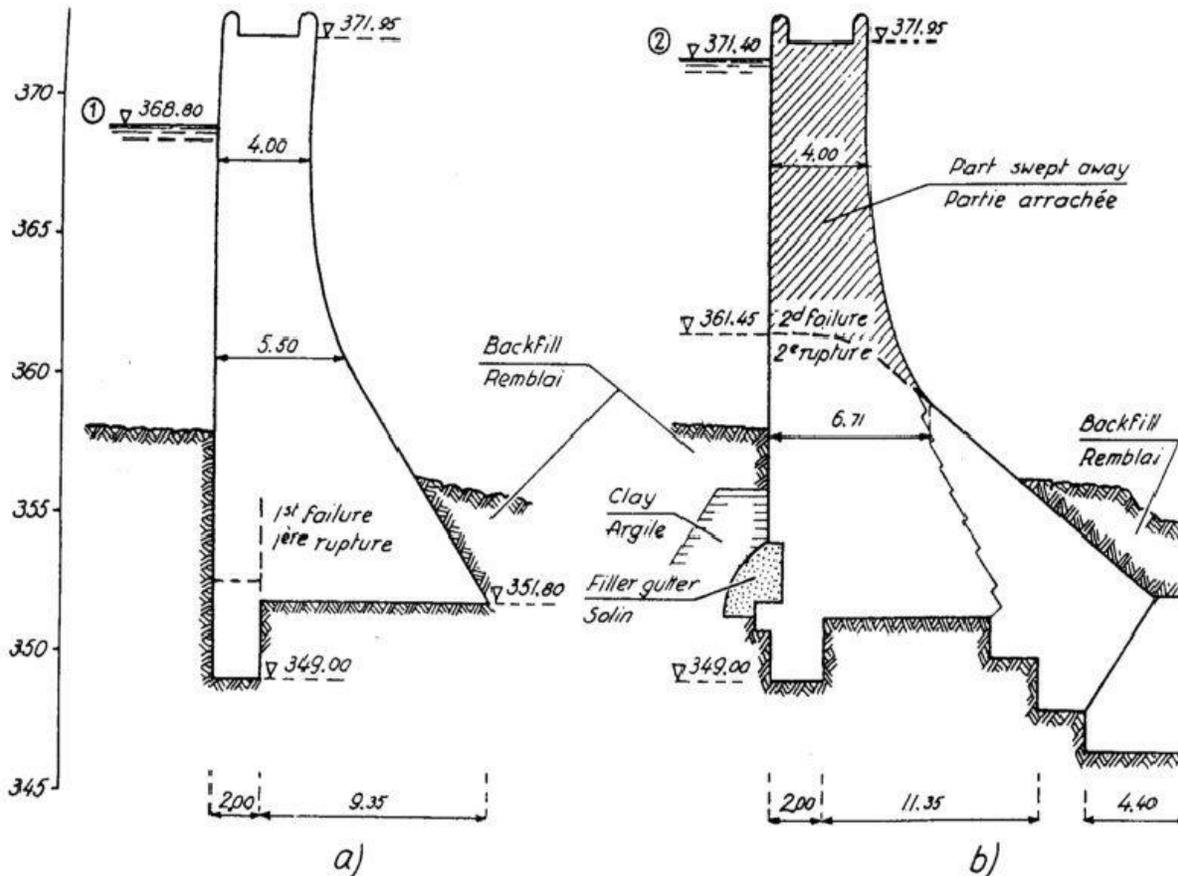
Figure showing part of Bouzey dam that was swept away.

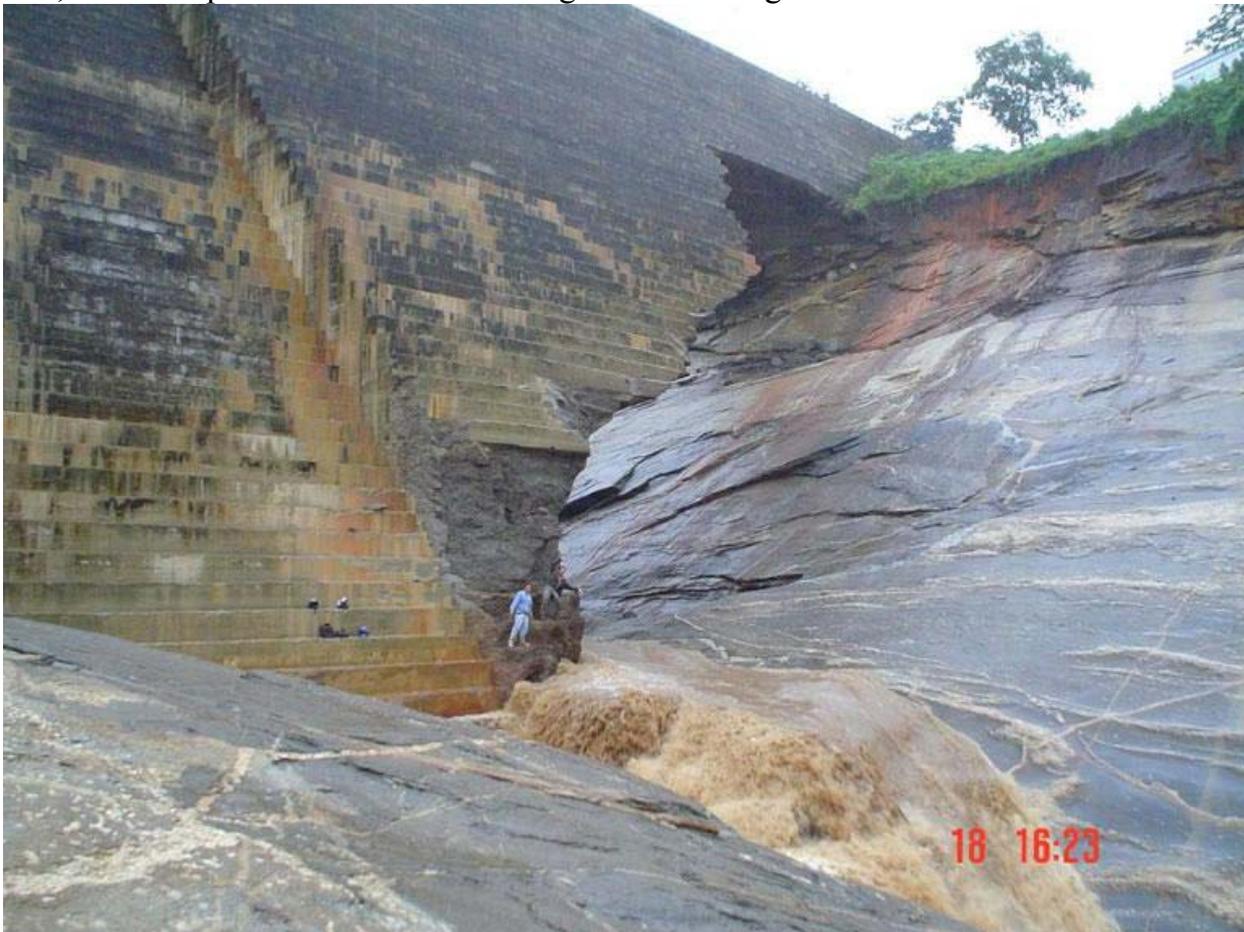
Post-failure analysis determined that during the design the assessment of the left abutment geology was not precise because some of the site geology was obtained from percussion drilling. A 12-inch thick soil fill was interpreted as being limited in depth to 10 feet into the abutment. The treatment of the left abutment was not sufficient and allowed the preservation of an extensive shear zone. The inspections were sporadic and leakage was ignored. A recommendation to drain the reservoir was ignored. Flowing reservoir water washed out the foundation material to the point that drains were being plugged. As a result, high pressure gradients developed under the dam. As the flow of reservoir water increased the erosion and driving forces on the low-shear strength rock slabs, they began to slide and fail in an upstream progressive manner until a hole was piped beneath the dam. The remaining slab of rock in left abutment is essentially fracture free, therefore percolation occurred along the entire length of the fracture.

It was thought that Shear Zone ZC only extended back into the foundation 10 feet because of the thinning of the bed. However, the zone was much more extensive.

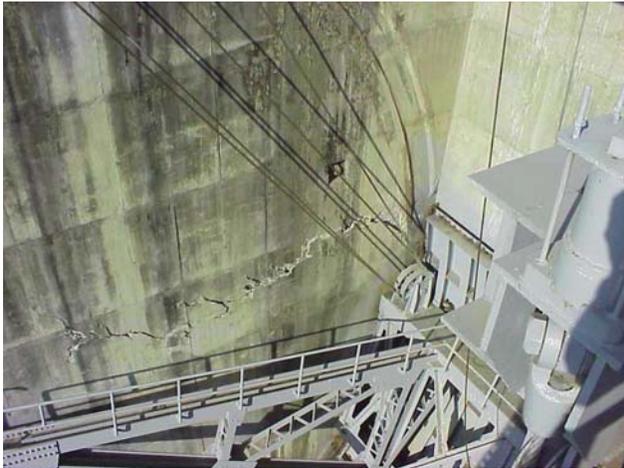
Pier Cracking

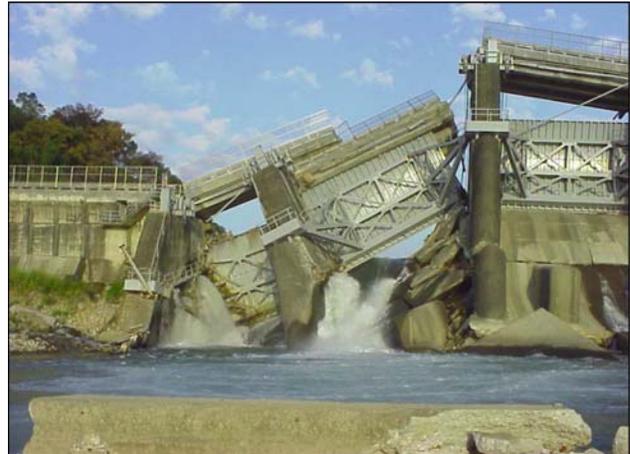
Bays 16-18: Right side rose 32 feet while the left side rose 7 feet

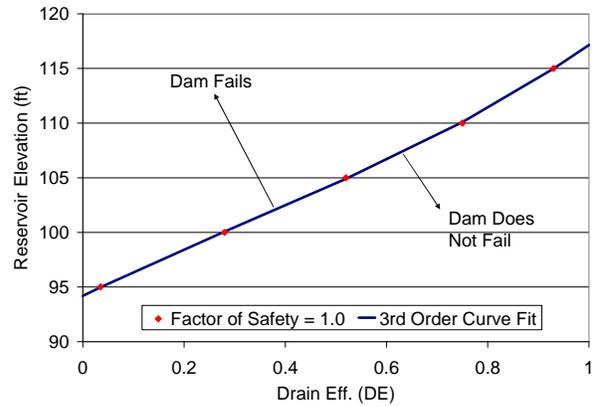
Fig. R5.4.3.1.1

These repeated analyses yield a relationship between reservoir elevation and drain effectiveness as can be seen adjacent. In a deterministic analysis, one specific drain effectiveness would be assumed, but in quantitative risk analysis, the uncertainty of drain effectiveness can be factored into the probability of failure. This adjacent curve can be used in conjunction with a curve that relates reservoir stage to annual probability of exceedence.

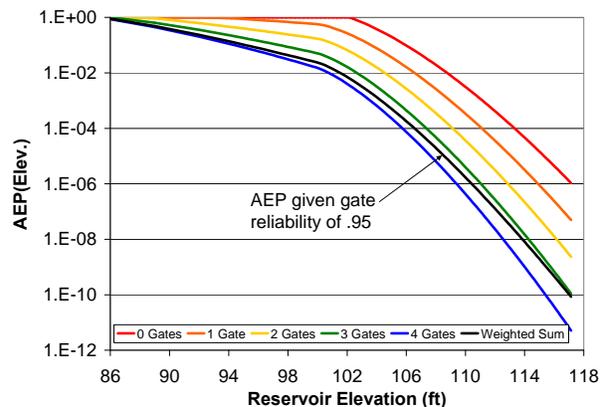
Since there are 5 different possibilities of gate performance, each with a non zero probability of occurrence, the processes of evaluation Eq. 2 must happen 5 different times, each with a spillway rating curve appropriate to the number of functioning gates. The $AEP_{Elev.s}$ using these 5 different spillway rating curves are then weighted by the values in Table 1 and summed to yield an $AEP_{Elev.}$ factored by

gate reliability. (See the black curve in Fig. R5.4.3.1.5)

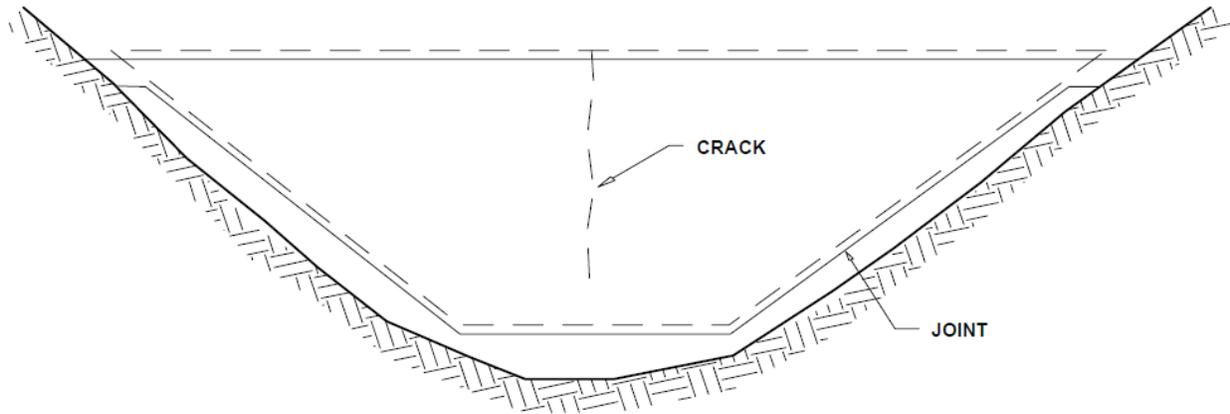
Field investigations indicated that the failure occurred possibly due to the upward and downstream sliding of the dam along a peripheral joint. The dam was built as a masonry structure composed of granite blocks in the main body of the dam and included a peripheral joint between the dam and its artificial concrete abutment. The joint surfaces were coated with bitumen and polyvinyl chloride was used to seal the joint.

Upward sliding of Plum Arch Dam along its artificial flat abutment.

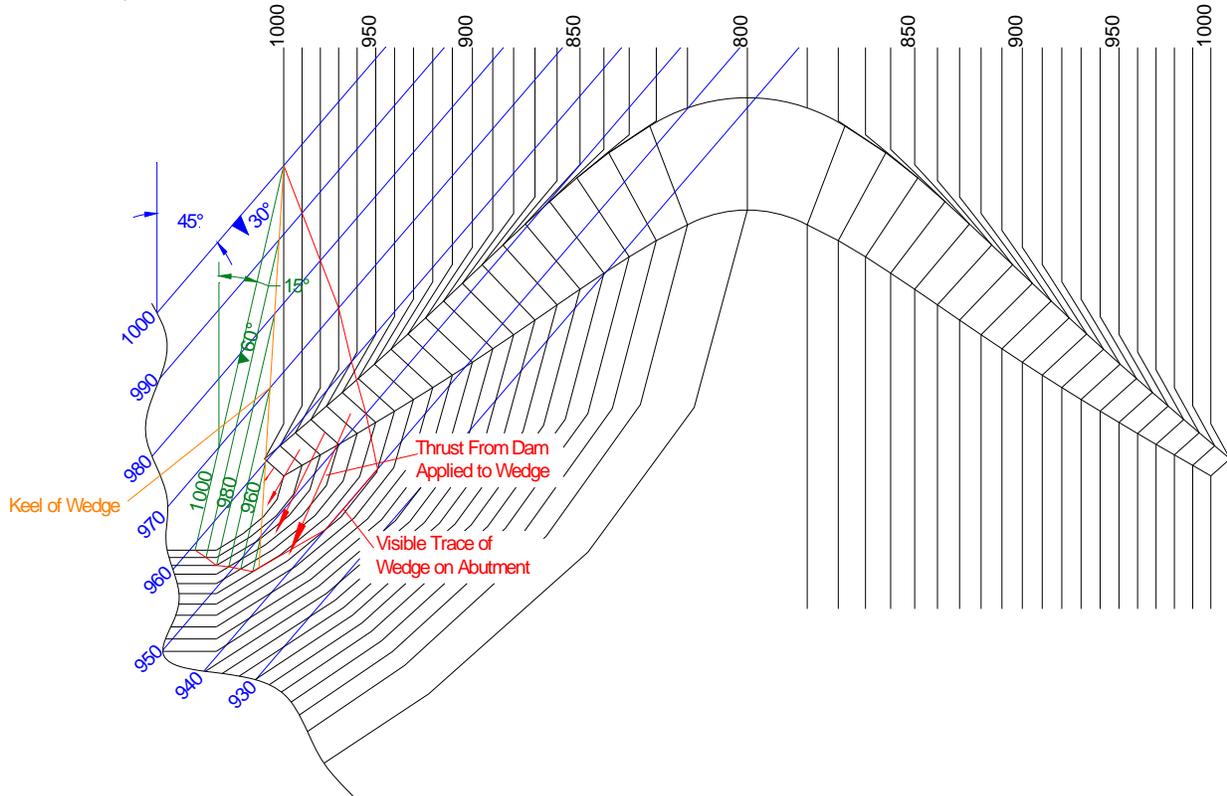
Fig. R5.5.2.1

This failure mode has a dramatic historical example in the Malpasset dam failure (See R5.5.1.1)

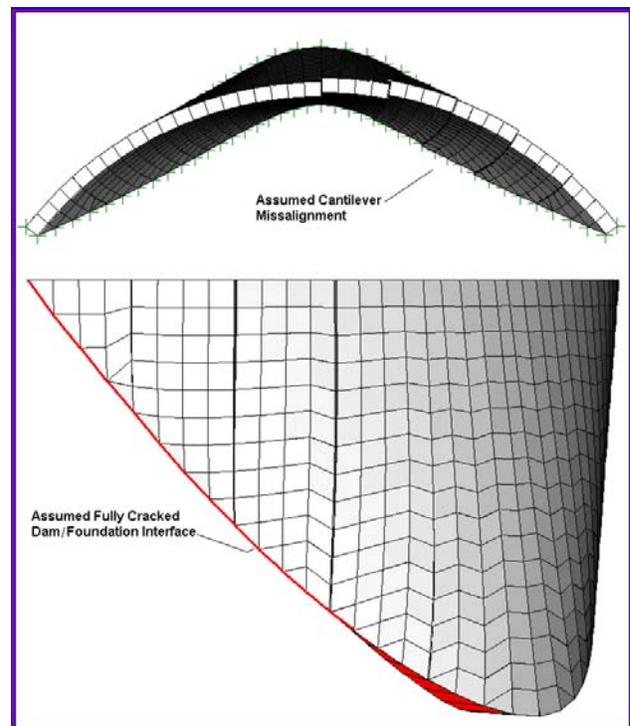
Fig. R5.5.3.2.1

One can always assume enough damage to fail the dam. The question then becomes “Are the damage assumptions reasonable?”. In this example, the assumed cantilever offsets were rather extreme. (5' max). The damage assumption must be appropriate to the magnitude and duration of shaking. Peak ground displacement should be considered. Assumed offsets should be somewhat tied to peak ground displacement. If for example, peak ground displacement was 6", 5 feet of assumed offset would be unreasonable, however if peak ground displacement was 30", 5 feet is more credible.

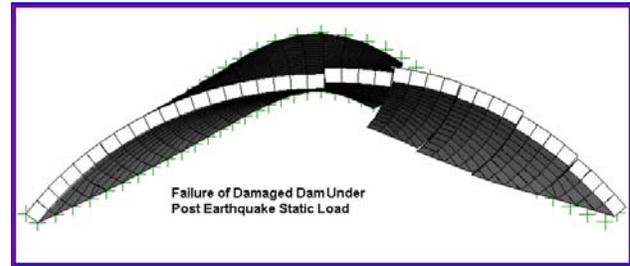
Fig. R5.5.3.2.2

The generation of a fragility curve is not necessary if it can be shown with reasonable confidence that the dam will not fail under an earthquake loading whose annual probability of exceedence is sufficiently small. It is not necessary to determine the earthquake magnitude that will fail the dam if acceptable performance can be demonstrated under events that are rare enough.

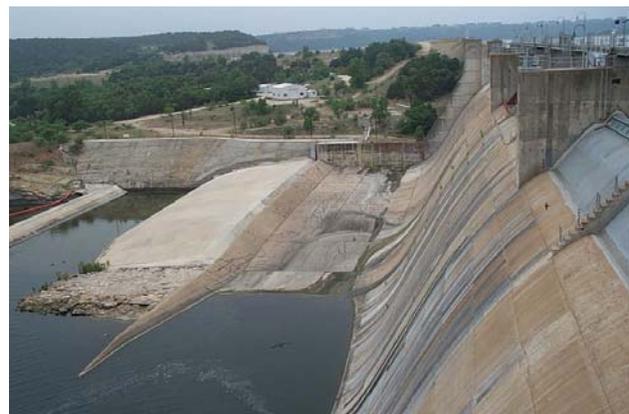
Morris Sheppard is a massive slab buttress dam with 40 buttresses. It was completed in 1941 across the Brazos River with a total length of 2740 feet. The dam design did not consider uplift pressures.

During a Federal Energy Regulatory Commission (FERC) mandated inspection,

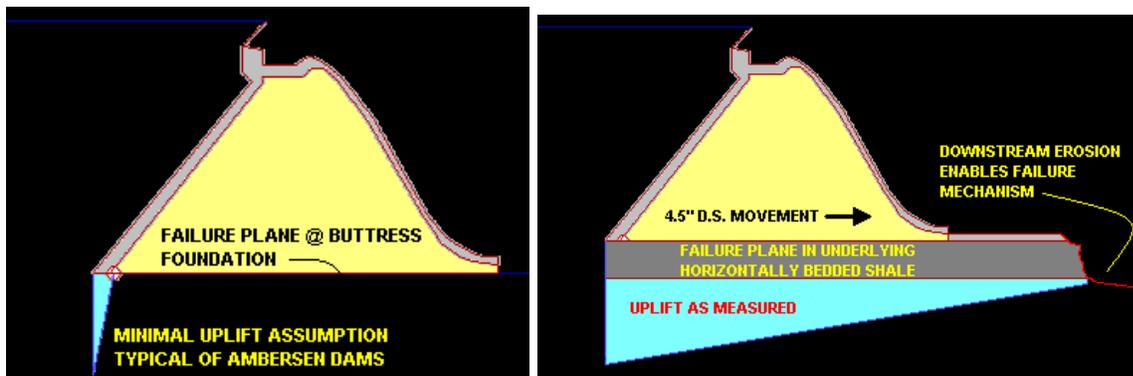
The dam had been constructed over a layer of shale which provided the failure plane. The uplift pressure at the buttress/foundation contact was minimal, however the uplift pressure in the shale was quite high, exacerbating the sliding problem. To remediate the dam a series of 6 inch diameter relief wells, spaced every 13 feet were planned, but some wells encountered pressure flows of up to 450 gallons per minute. A total of 147 wells, some as large as 12 inches in diameter, were installed in an attempt to lower the hydrostatic pressure on the failure plane. The factor of safety against sliding was calculated as 1.5 after the first phase of modifications was completed. Subsequent modifications, such as the addition of ballast to the spillway bays to increase the weight resisting the uplift forces, would bring the factor of safety against sliding to 1.75.

Safety factor of 1.4

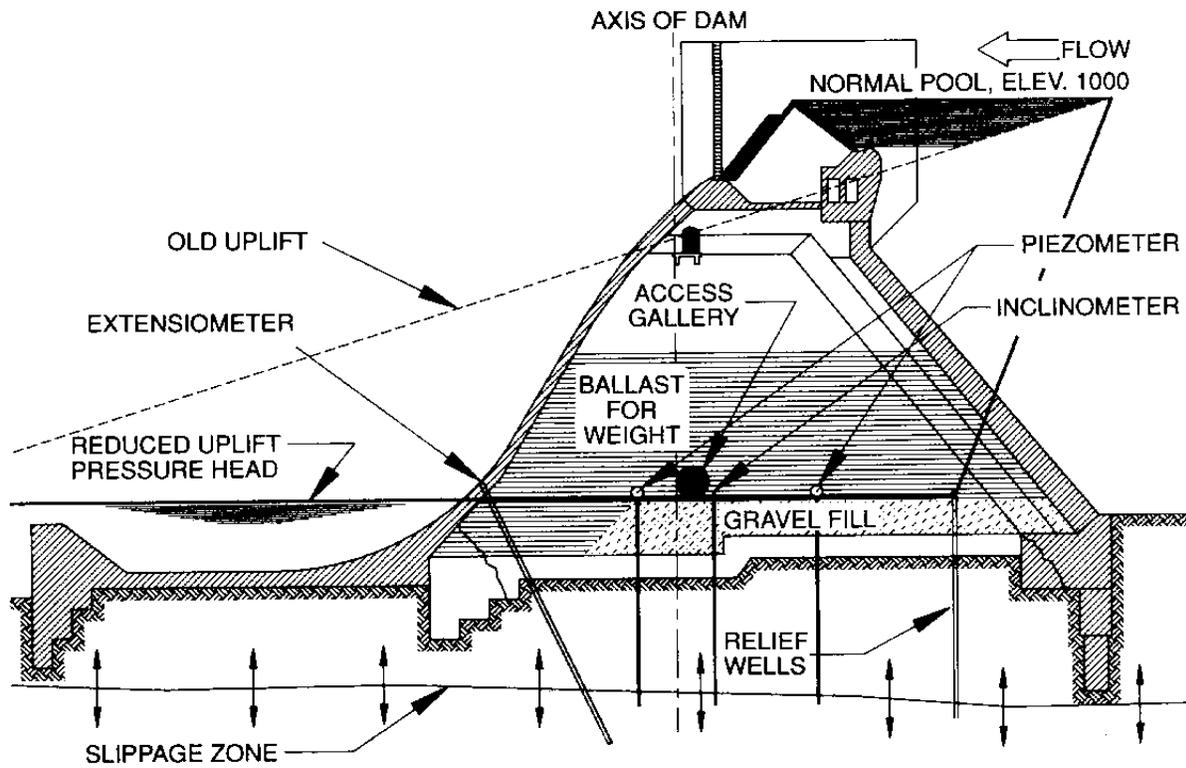
Retrofits at Morris Sheppard Dam

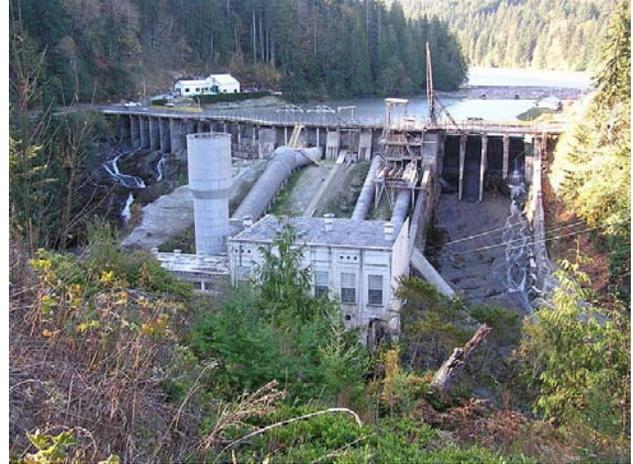
The Elwha Dam is located on the Elwha River approximately 4.9 miles upstream from the mouth of the river on the Strait of Juan de Fuca. The dam was built under the direction of Thomas Aldwell. He began construction of the Elwha Dam in 1910.

Aldwell and his contractors cut corners on constructing the dam and did not secure it to the bedrock. Thus, in October 1912, as the reservoir filled behind the nearly completed dam, a piping failure of the alluvium under the dam occurred. This caused the lower sections of the dam to give way and a torrent of water took out a bridge. About 10,000 acre feet passed under the dam in about 2 hours, causing a hole that was 75' deep at the upstream face and 90' deep at the downstream face. The main portion of the dam continued to span the hole. This failure caused extensive property damage but no loss of life.

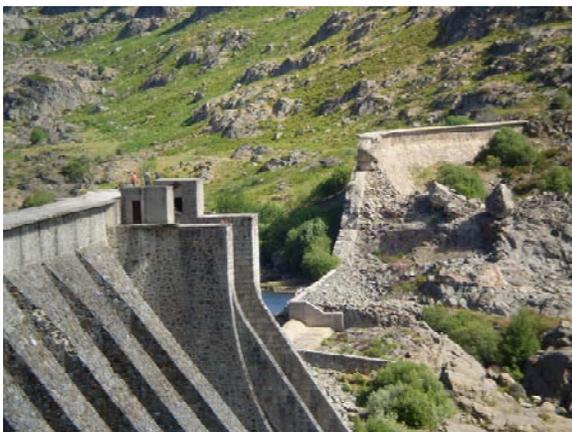
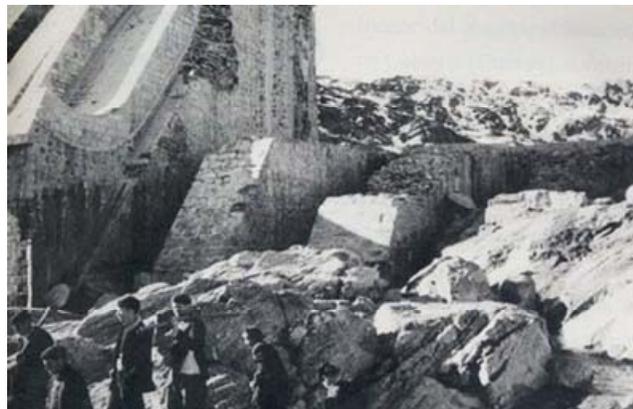
The dam failed on January 10, 1959 after heavy rains filled the reservoir to the maximum level for a few days. A micro-seismic shock was recorded at Coimbra in Portugal almost coincidental with the failure. There was a successive collapse of 17 buttresses that released 6,300 acre-feet in a very short period of time. Failure occurred in the depth of winter so no post-failure inspection was done until April 1959.

As can be seen in the photos above, the

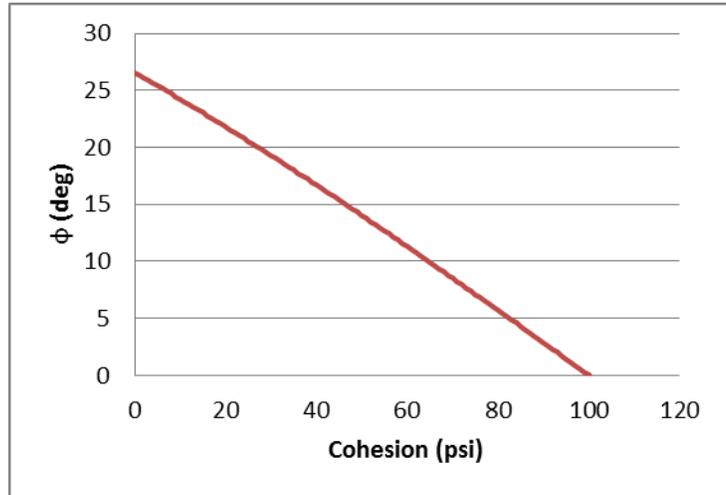
$$\Pr(\text{Failure}) = \int_0^{\tau} \text{PDF}(C) * (\text{Cum Pr}(\phi)) \delta C$$

This can be integrated numerically using Excel functions such as Norm.Dist. The result is a failure probability of 1.1%.

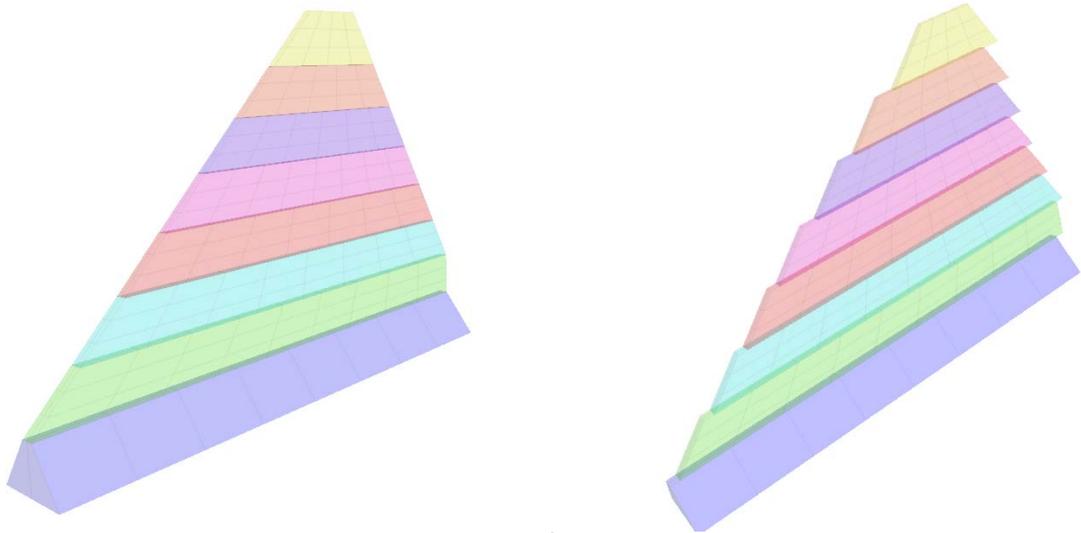
The figure below shows the displacement of the buttress sections downstream before and after the seismic event.

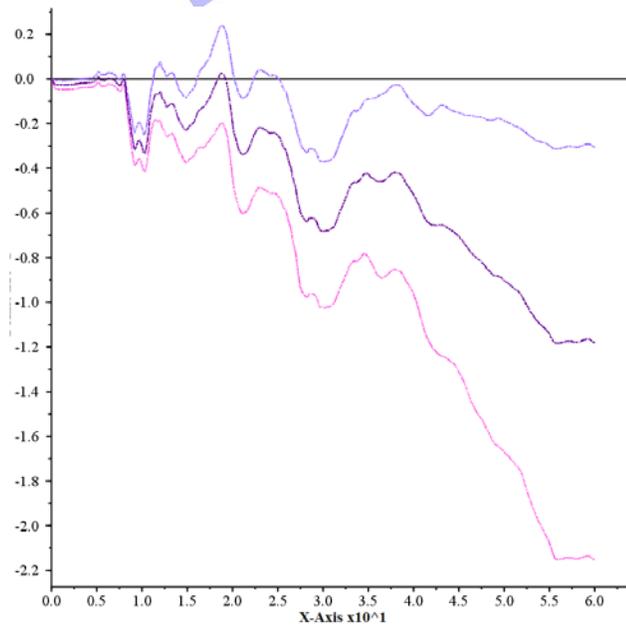
The adjacent figure shows the displacement of different lifts of the buttress during the seismic event. As can be seen in the graph, during the earthquake, the buttress lifts progressively walk downstream. There is no one area of significant
