# Arizona-Southern California Outages on September 8, 2011

## Causes and Recommendations

Prepared by the Staffs of the  
Federal Energy Regulatory Commission  
*and the*  
North American Electric Reliability Corporation

**April 2012**

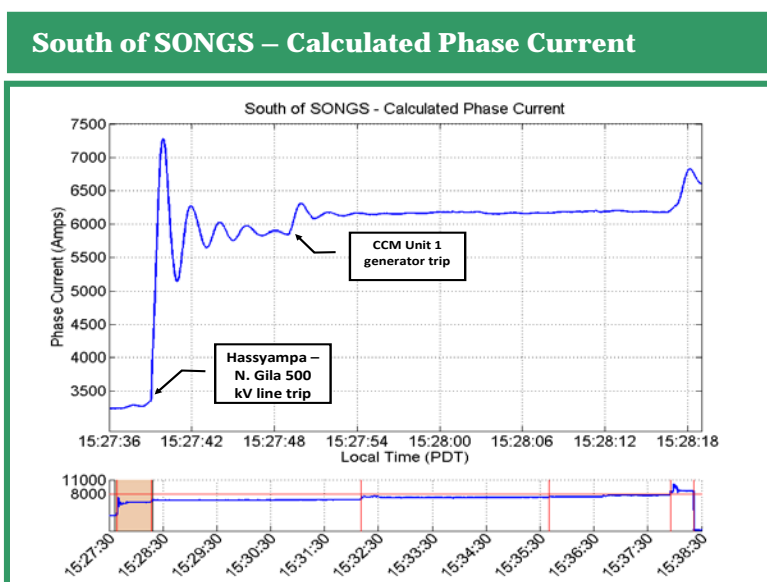
triggered by transients.<sup>41</sup> caused by the initial fault at North Gila and subsequent trip of H-NG. Loss of this unit further increased the flow on Path 44, raising the current to 6,200 amps out of the 8,000 needed to initiate the SONGS separation scheme. However, the La Rosita trip alone was not significant in causing the cascading that followed.<sup>42</sup> CFE was also unaware in real time that H-NG had tripped. After losing the Central La Rosita unit, CFE was unable to recover its ACE with its own resources, and at 15:30, it requested 158 MW of emergency assistance from CAISO for the remainder of the hour.

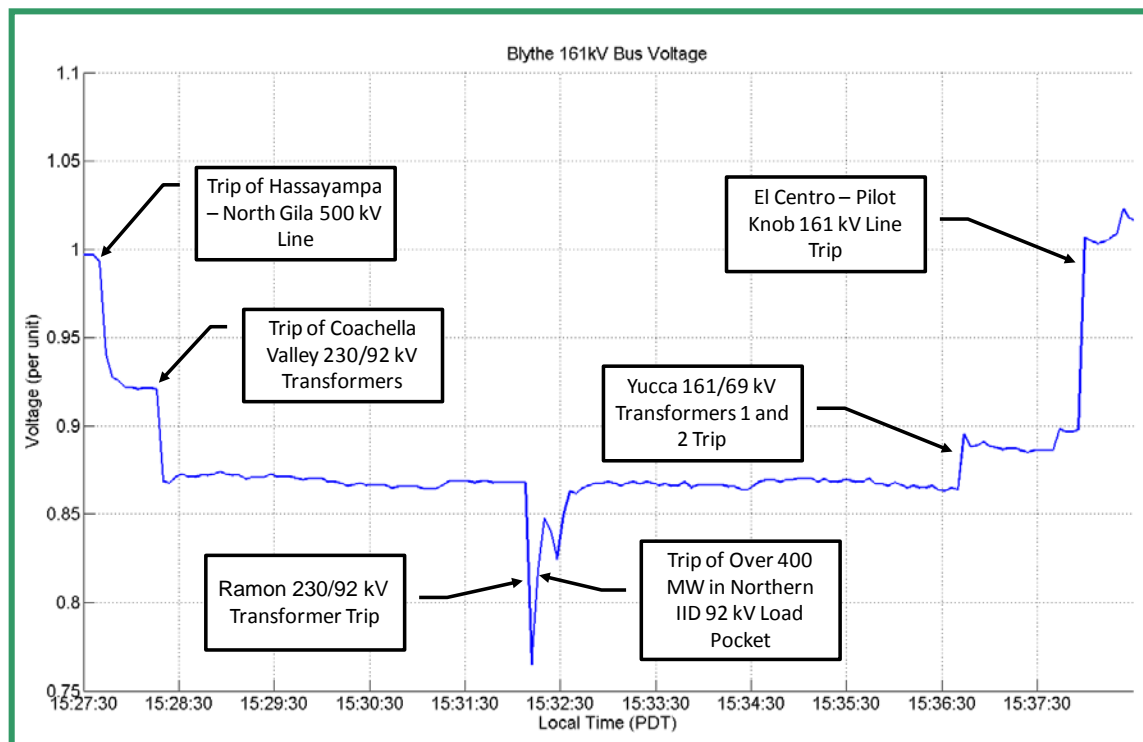
**Figure 8: Blythe 161kV Voltage**

The loss of the CV banks caused a severe voltage depression on the WALC 161 kV system south of Blythe. During this period, loads in that area (largely irrigation pumps) were highly susceptible to motor stalling, which can create additional reactive demand and exacerbate transmission loading, both of which contribute to additional voltage decline. See **Figure 8**, on the next page. At 15:28:18, the Blythe 161 kV bus alarmed at 142 kV (0.882 per unit).<sup>45</sup> WALC continued to experience severe low voltage on its 161 kV system until the S Line tripped at 15:38:02.4.

<sup>45</sup> Other alarms and low voltage readings followed throughout WALC's system one to nine seconds later, including the Parker-Kofa 161 kV line, which alarmed for overload at 169 MVA (167 MVA rating); Kofa 161 kV bus voltage recorded at 143 kV (0.888 per unit); Knob 161 kV bus voltage recorded at 142 kV (0.882 per unit); Parker 161 kV bus voltage recorded at 149 kV (0.925 per unit); Gila and Goldmine 161 kV bus voltages recorded at 144 kV (0.894 per unit); and Parker 230 kV bus voltage recorded at 222 (0.965 per unit).

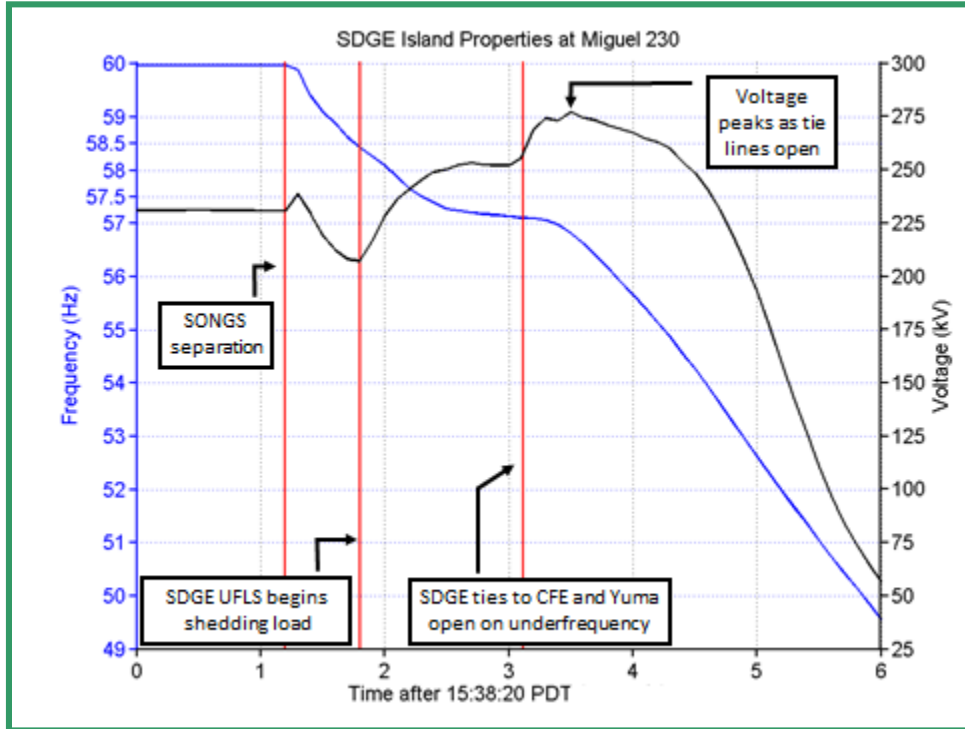
**Figure 10: Frequency, Voltage in the SDG&E/Yuma/CFE Island**

The SDG&E/CFE/Yuma island created by operation of the SONGS separation scheme had a significant imbalance between generation and load from the beginning. As a result, the frequency in the island rapidly declined. By less than a second after the SONGS separation scheme activated (15:38:22), the UFLS programs of SDG&E, APS, and CFE had all begun activating within the island. *Figures 10 and 11*, below show the frequency within the island as it collapses. All steps of the UFLS systems activated and system frequency in the island briefly stalled at approximately 57.2 hertz (Hz). CFE's UFLS analysis showed 512 MW of load shed by 15:38:21.901.

However, the same analysis showed that three CFE generators, totaling 459 MW, tripped offline beginning at 15:38:21.905, partially negating CFE's UFLS actions. In addition, a number of smaller generators, totaling about 130 MW, tripped only 0.5 seconds later while CFE was still connected to SDG&E and while SDG&E's UFLS program was still working to shed load.<sup>54</sup> See *Figure 11*, below. The net effect of CFE's UFLS actions and generator trips—512 MW shed by UFLS and 590 MW of tripped generation—was that CFE's imports from SDG&E increased from approximately 440 MW to approximately 520 MW. This worsened CFE's system conditions and increased the stress on SDG&E before SDG&E's underfrequency separation protection systems opened the ties between CFE and SDG&E. SDG&E also had three generators with underfrequency protection that operated at 57.3 Hz, above the frequency at which the system leveled out. Due to these early generation losses, the frequency continued to decline below 57 Hz, which was the underfrequency setting for the majority of generators in the island. Thus, the island blacked out, shortly after separating into three sub-islands.

<sup>54</sup> The fact that several generators tripped during load shedding suggests that CFE may benefit from analyzing whether its UFLS program and generator underfrequency protection systems are coordinated.

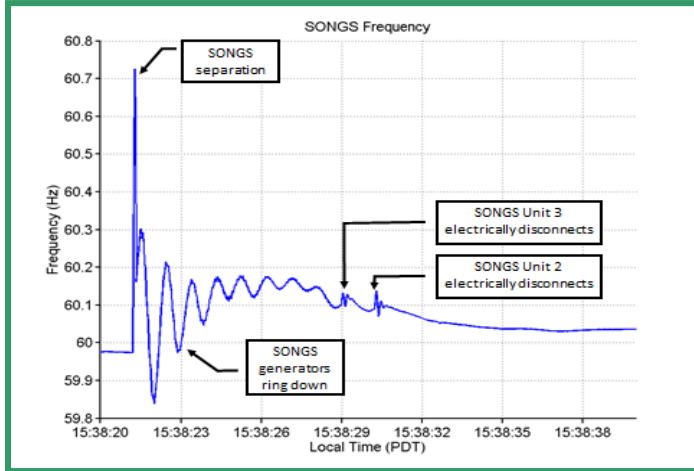
**Figure 12 : Frequency Excursion in WECC Interconnection Immediately after the SONGS**

Loss of the 2,300 MW of SONGS' generation effectively reduced the loss of load for the main body of the Western Interconnection from a 3,400 MW loss to a net 1,100 MW load loss. This made the recovery from the resulting overfrequency event much easier. The SONGS generators did not lose offsite power because the SONGS switchyard was still connected to the SCE system.

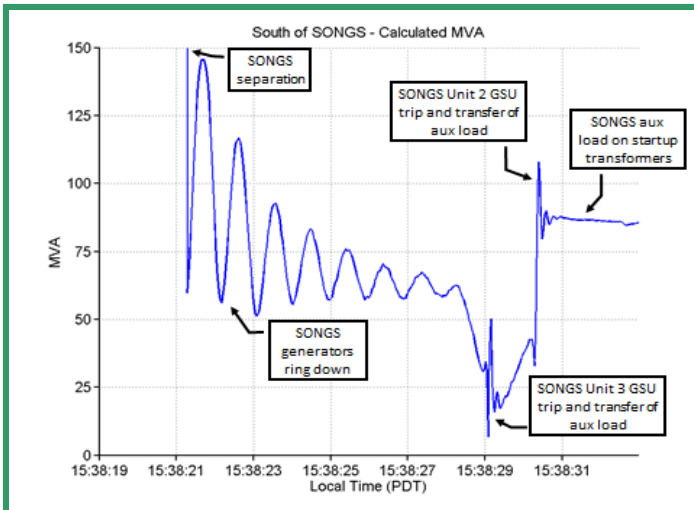
**Figure 13: SONGS Generation Trips and Auxiliary Loads Transfer to 230 kV Bus**

Although the SONGS generators remained connected to the SCE side of the switchyard at SONGS, at about 15:38:27.5, or approximately six seconds after the SONGS separation scheme initiated, the SONGS turbines both experienced a brief acceleration in speed and tripped due to turbine control logic. At the same time, local system frequency at SONGS was observed to spike from 59.974 Hz to 61.203 Hz. After the initial impulse caused by the system separation, the frequency in the main body of the Western Interconnection peaked near 60.170 Hz. This can be seen on Figures 12 and 13, on the next page. The turbine trip initiated a reactor shutdown, and the units began coasting down. A little more than a second later, at 15:38:28.963, SONGS Unit 3 electrically disconnected from the system, and less than three seconds after the reactors shut down, at 15:38:30.209, SONGS Unit 2 electrically disconnected from the system.
