5. How and Why the Blackout Began in Ohio

Summary

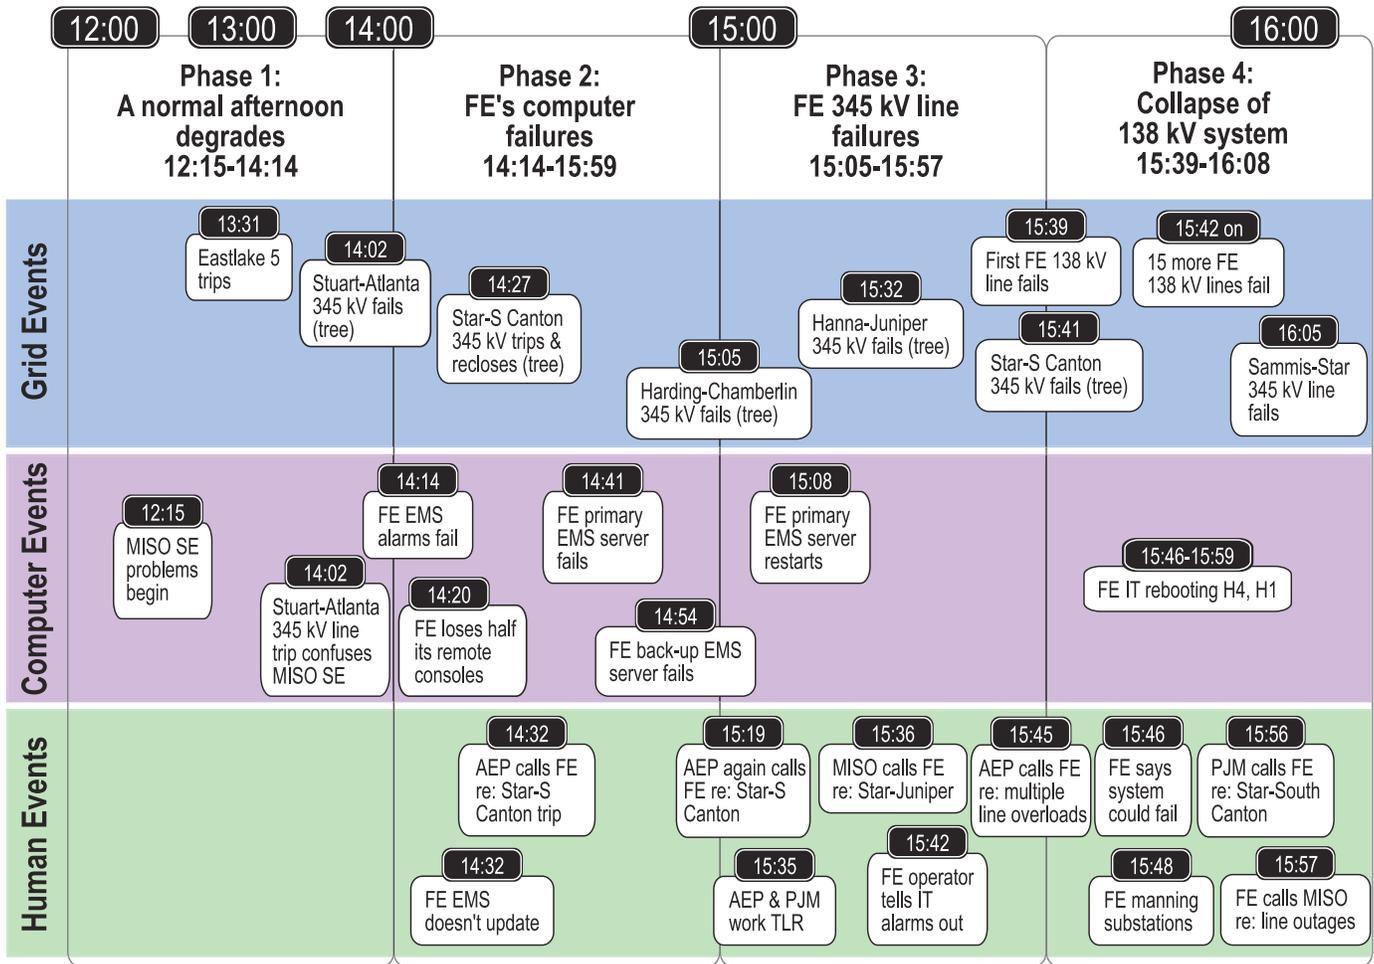
Figure 5.1. Timeline: Start of the Blackout in Ohio

Key events within each phase are summarized in Figure 5.1, a timeline of major events in the origin of the blackout in Ohio. The discussion that follows highlights and explains these significant events within each phase and explains how the events were related to one another and to the cascade. Specific causes of the blackout and associated recommendations are identified by icons.

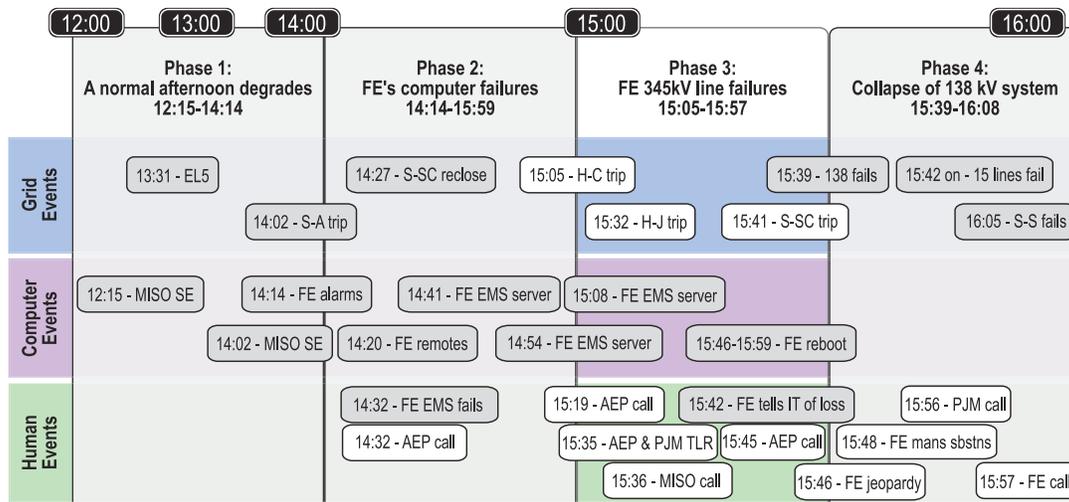
Figure 5.7. Timeline Phase 3

contacted a tree three times between 14:27:15 EDT and 15:41:33 EDT, opening and reclosing each time before finally locking out while loaded at 93% of its emergency rating at 15:41:35 EDT. Each of these three lines tripped not because of excessive sag due to overloading or high conductor temperature, but because it hit an overgrown, untrimmed tree.²²

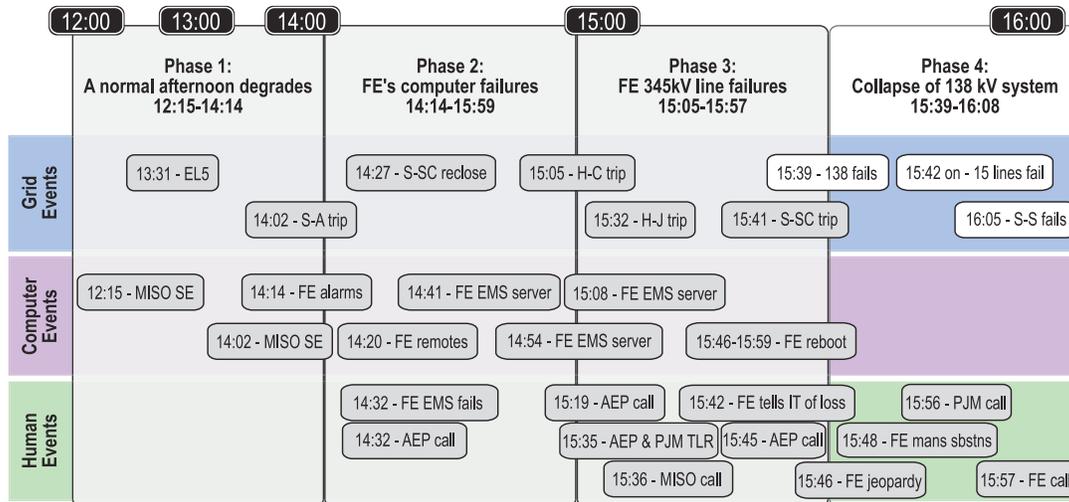
Figure 5.13. Timeline Phase 4

As each of FE’s 345-kV lines in the Cleveland area tripped out, it increased loading and decreased voltage on the underlying 138-kV system serving Cleveland and Akron, pushing those lines into overload. Starting at 15:39 EDT, the first of an eventual sixteen 138-kV lines began to fail (Figure 5.13). Relay data indicate that each of these lines eventually ground faulted, which indicates that it sagged low enough to contact something below the line.

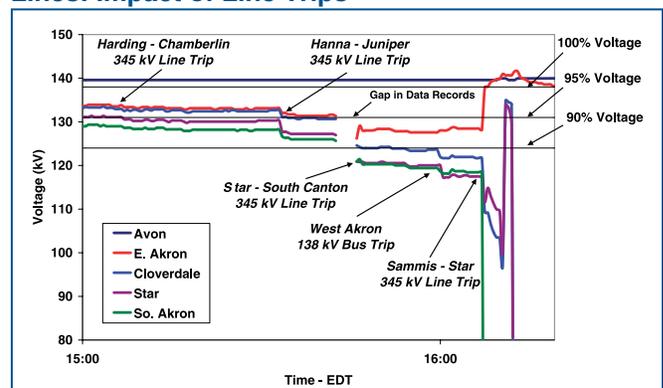
Figure 5.14. Voltages on FirstEnergy’s 138-kV Lines: Impact of Line Trips

Figure 5.14 shows how actual voltages declined at key 138-kV buses as the 345- and 138-kV lines were lost. As these lines failed, the voltage drops caused a number of large industrial customers with voltage-sensitive equipment to go off-line automatically to protect their operations. As the 138-kV lines opened, they blacked out customers in Akron and the areas west and south of the city, ultimately dropping about 600 MW of load.
