**Subject: Silver Lake Dam (P-10855)
FERC Independent Consultants Review Panel Report
Comments of MWH Americas, Inc.**

The Panel Report Confirms the Adequacy of the Fuse Plug Design

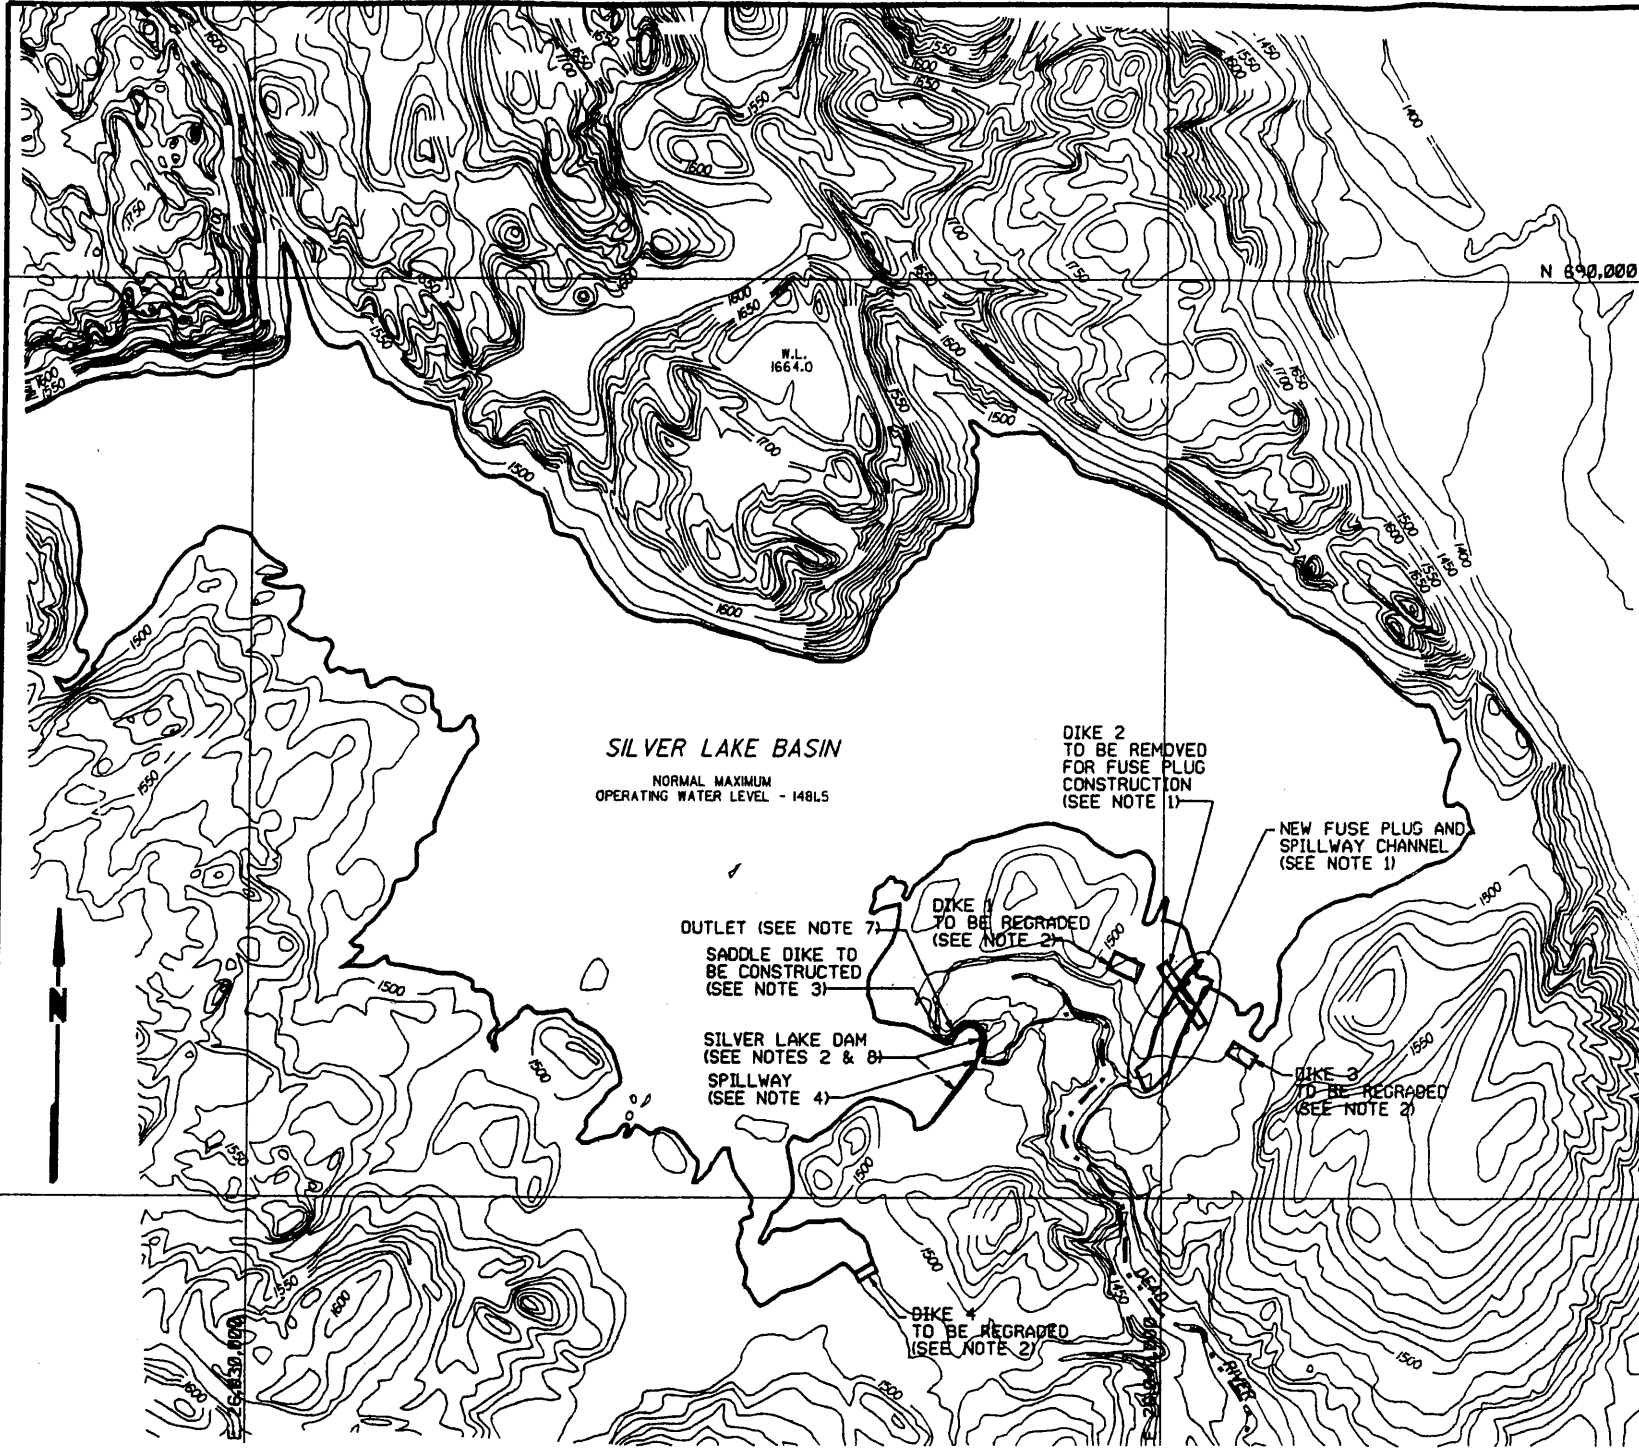
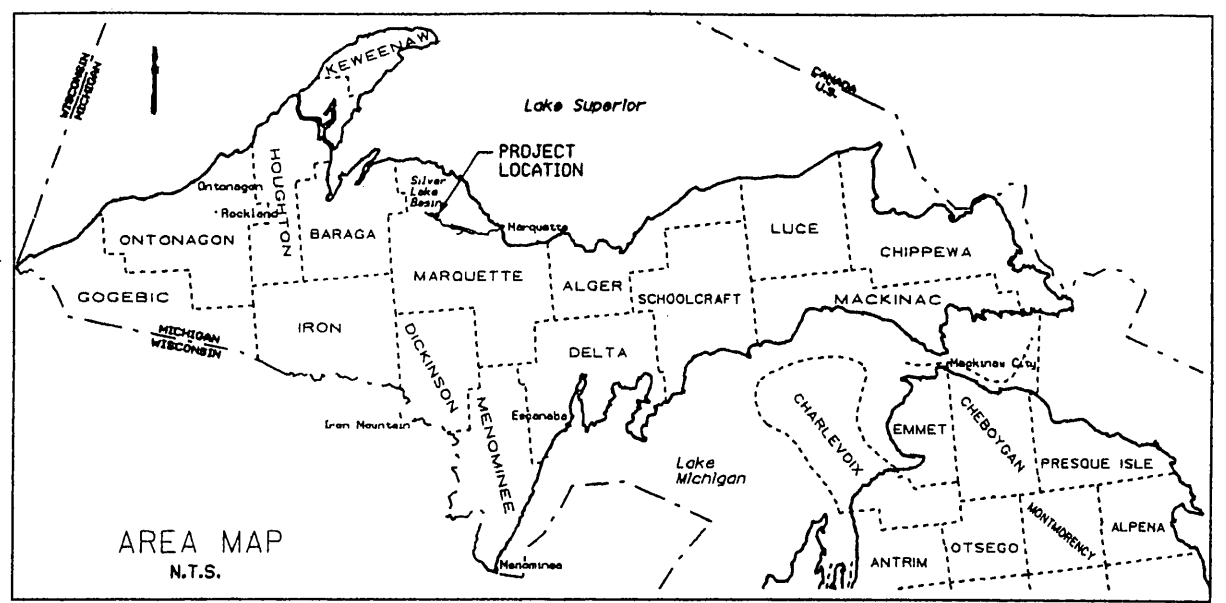
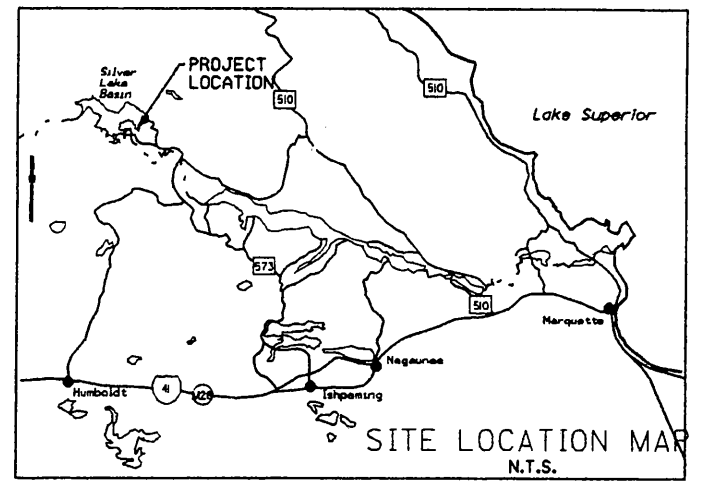
CHICAGO, ILLINOIS DATE DWG. NO. 20895-C1

INDEX OF DRAWINGS	
NUMBER	TITLE
20895-C1	AREA MAP, SITE LOCATION MAP AND SITE PLAN
20895-C2	MAIN DAM PLAN
20895-C3	MAIN DAM AND SPILLWAY SECTIONS AND DETAILS
20895-C4	CONCRETE OUTLET STRUCTURE SECTIONS AND DETAILS
20895-C5	SADDLE DIKE PLAN AND CROSS SECTION
20895-C6	FUSE PLUG AND SPILLWAY CHANNEL PLAN AND PROFILE
20895-C7	FUSE PLUG PROFILE AND CROSS SECTIONS

In addition to the clear legal obligations of its FERC license, as the owner and operator of the Silver Lake Reservoir, UPPCO had a duty to downstream riparians and the general public to operate the reservoir to avoid overfilling. To guard against overfilling, the stoplogs should have been removed – as a baseline condition – to 1482.5 feet. This point was emphasized by MWH in its 2001 and 2002 Design Reports and by FERC in a letter to UPPCO dated May 16, 2002 – a full year before the breach. Further, UPPCO was fully aware that stoplog removal to 1482.5 feet was an integral part of the construction project. *See* exhibits 1 and 2 enclosed with this letter — Construction Drawing C-1 (Exh. 1), submitted to UPPCO on May 29, 2001 (Exh. 2).

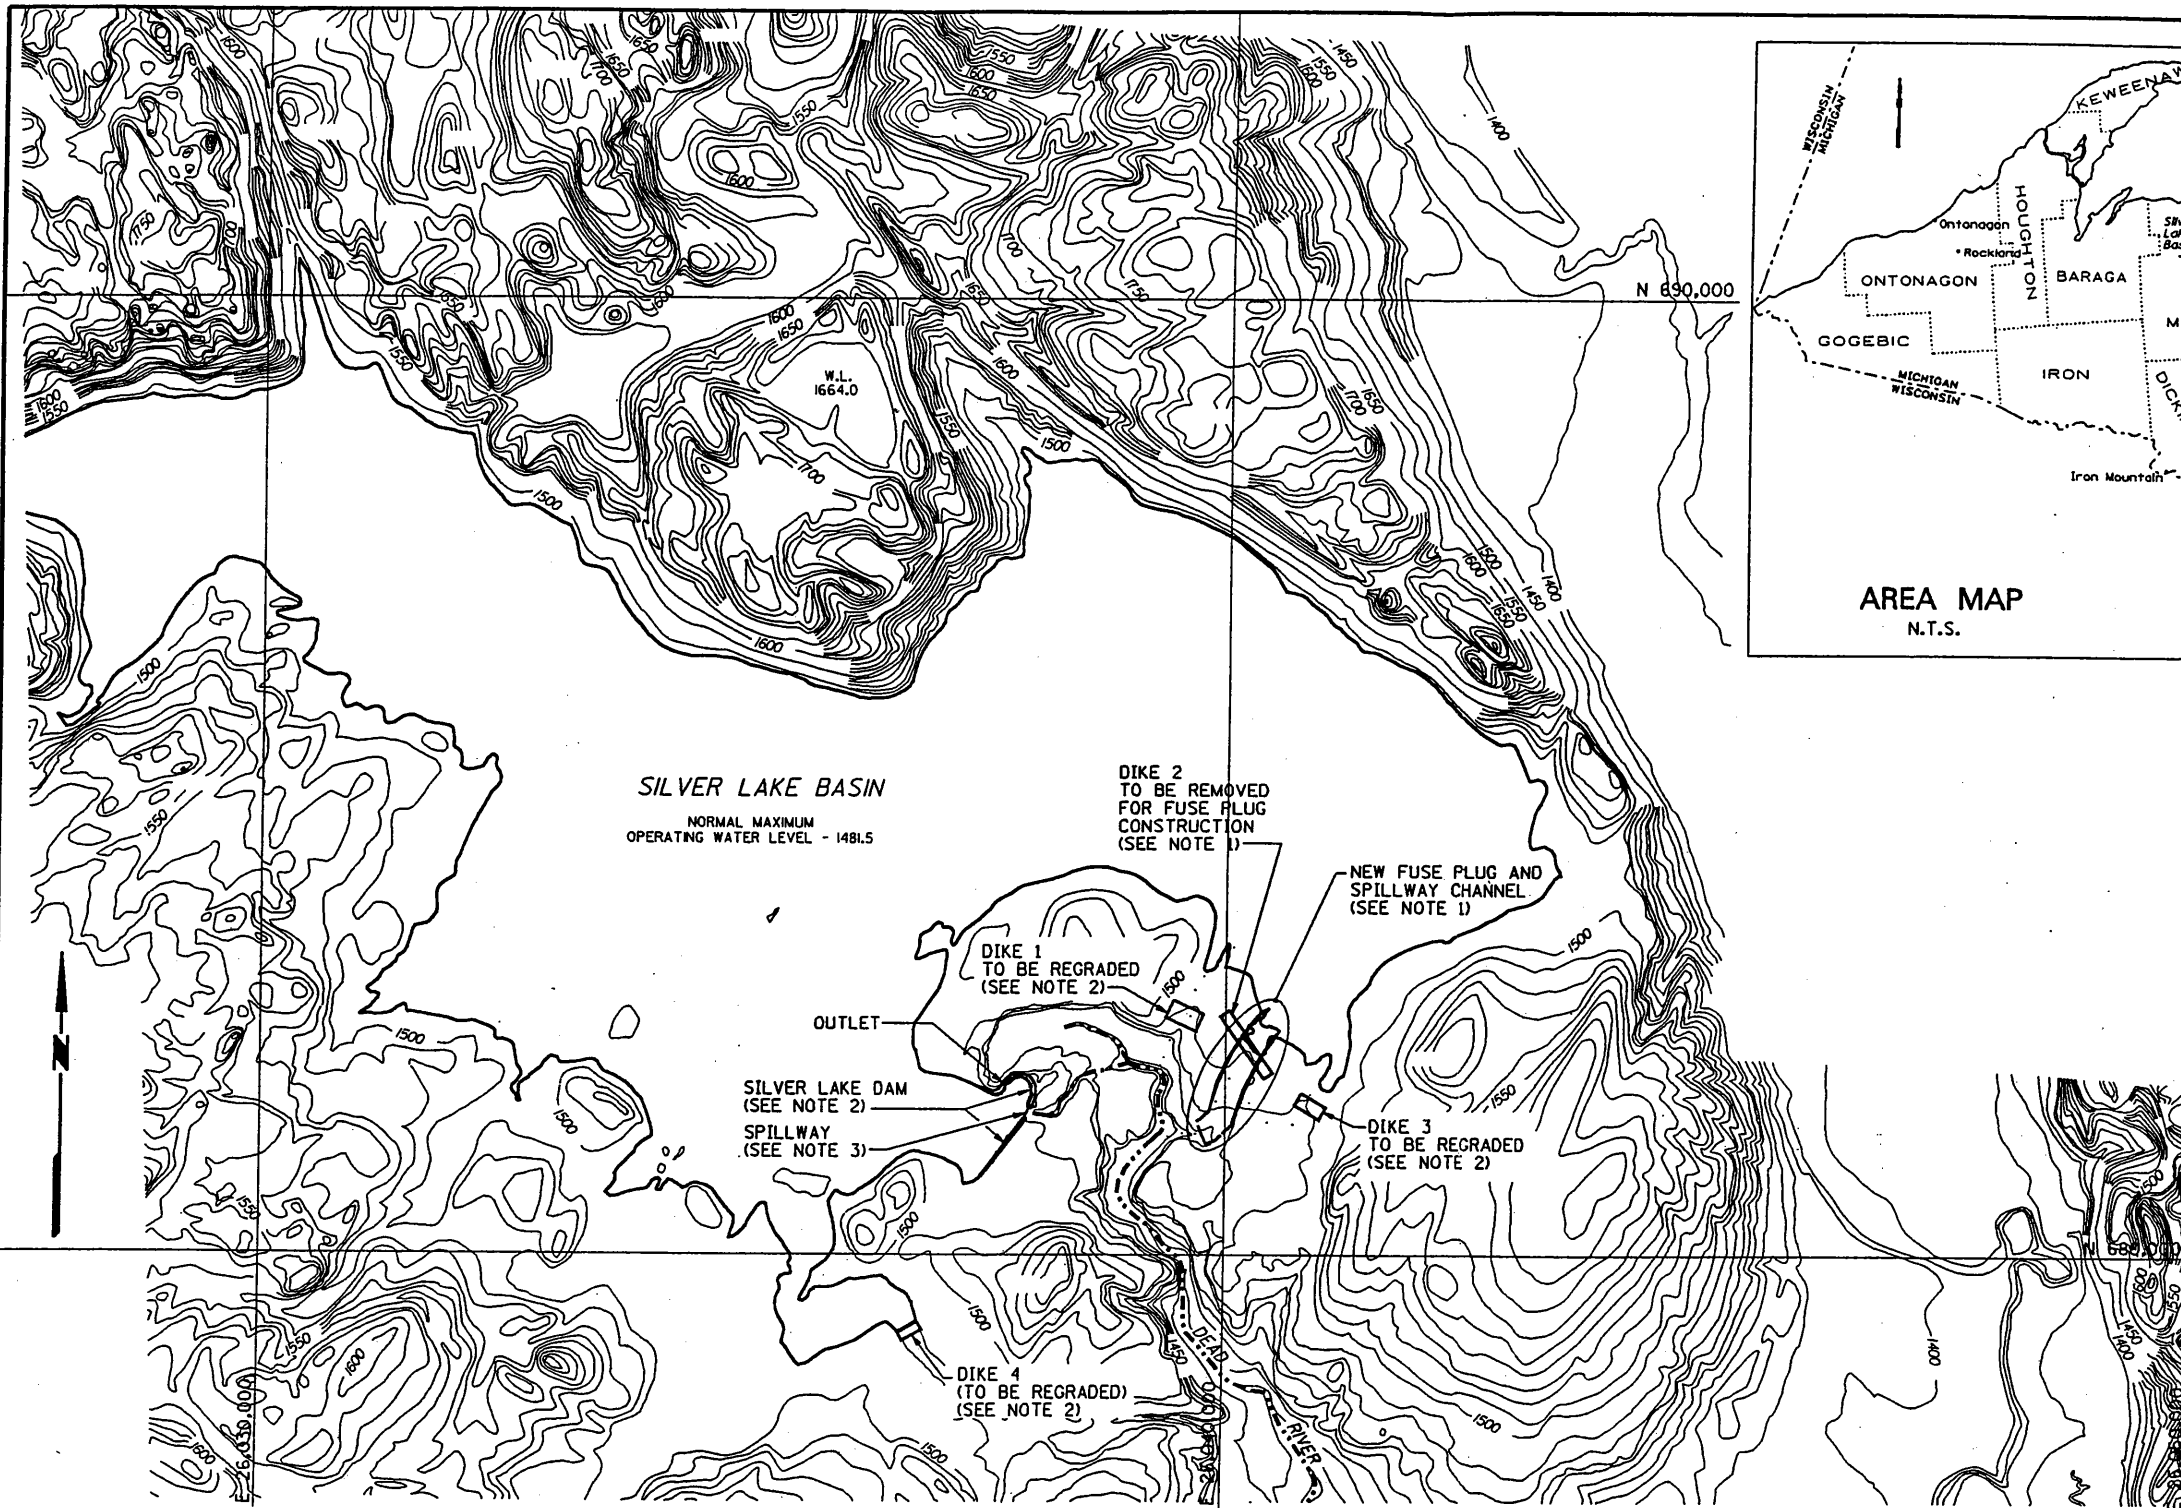
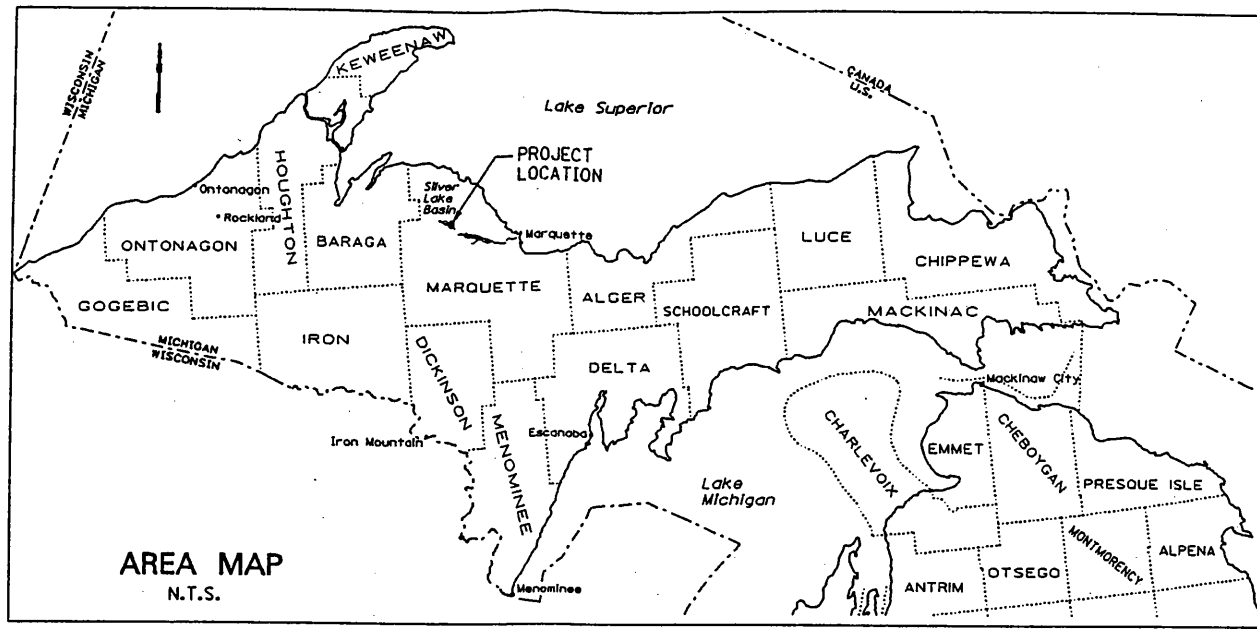
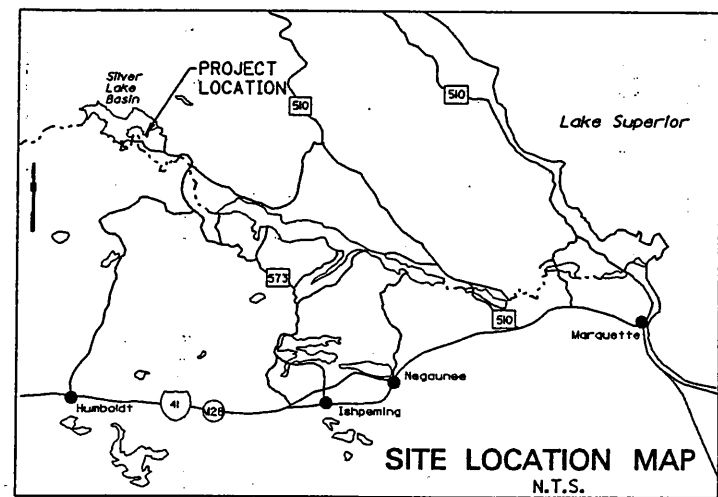
- NOTES:
1. DETAILS OF REMOVAL OF DIKE 2 AND WORK TO BE PERFORMED BY CONTRACTOR FOR CONSTRUCTION OF NEW FUSE PLUG AND SPILLWAY CHANNEL ARE SHOWN ON DRAWINGS 18305G-02 AND 18305G-03.
 2. CONTRACTOR SHALL REGRADE EXISTING DAM AND DIKE FILLS TO EL. 1491.5 USING SUITABLE MATERIAL RECOVERED DURING REMOVAL OF DIKE 2 IN ACCORDANCE WITH THE SPECIFICATIONS.
 3. CONTRACTOR SHALL REMOVE WOODEN STOPLOGS FROM FOURTH SPILLWAY BAY FROM THE LEFT TO ELEVATION 1482.5. STOPLOGS ARE CURRENTLY IN PLACE TO ELEVATION 1486.5 IN ACCORDANCE WITH THE SPECIFICATIONS.
 4. HORIZONTAL PROJECT DATUM IS MICHIGAN STATE PLANE COORDINATE SYSTEM, NAD 83/86, NORTH ZONE. VERTICAL PROJECT DATUM IS NGVD 1929.
