ENGINEERING GUIDELINES FOR THE EVALUATION OF HYDROPOWER PROJECTS

CHAPTER 12 – WATER CONVEYANCE

AUGUST 7, 2018
FEDERAL ENERGY REGULATORY COMMISSION
888 First Street, NC
Washington, DC 20426

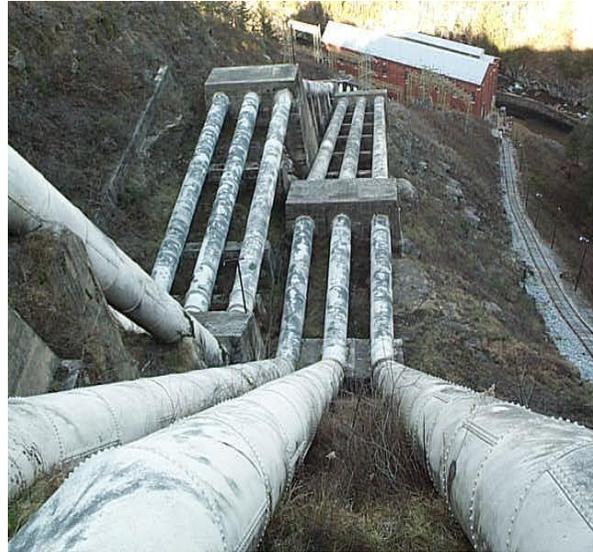
A view of typical riveted penstocks is shown in Figure 1. When penstocks are above ground as these are, they are usually mounted on concrete or steel saddle supports.

Fig. 1. Steel penstocks.

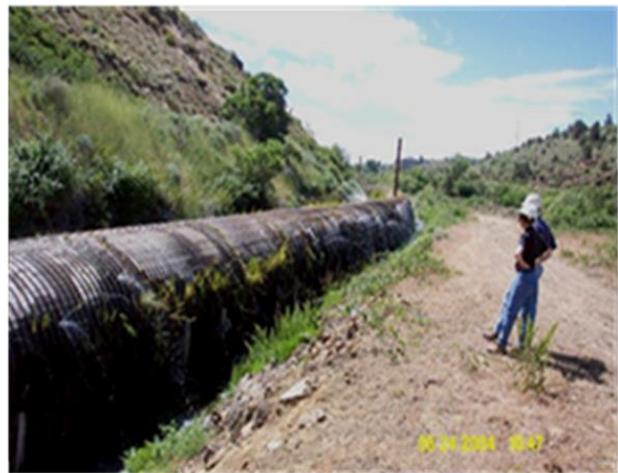
Woodstave penstocks are also used at hydropower projects to a lesser extent. These are typically constructed of creosote treated wooden strips called staves ringed with steel bands. The bands are typically spaced at about 1 ft. or less. Wood stave penstocks are limited to low internal pressures. As can be seen in the picture below, they often leak profusely. This can result in saturation of the ground underneath them leading to support instability.

Fig. 2. Woodstave penstock.

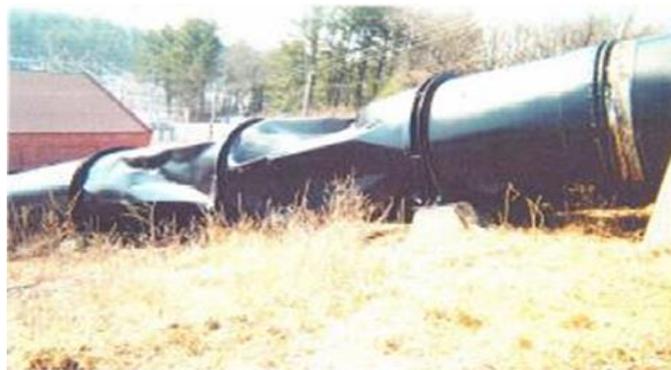
This failure mode is quite common and is typically the result of a sudden closure of an upstream inlet gate or plugging of the inlet while operating, and the failure of the air venting system. Air vents are sometimes plugged with debris or ice. In most cases it takes very little vacuum to buckle a penstock (Figure 4), therefore sufficient air venting directly downstream of an upstream gate must be provided.

Fig. 4. Buckled steel penstock.

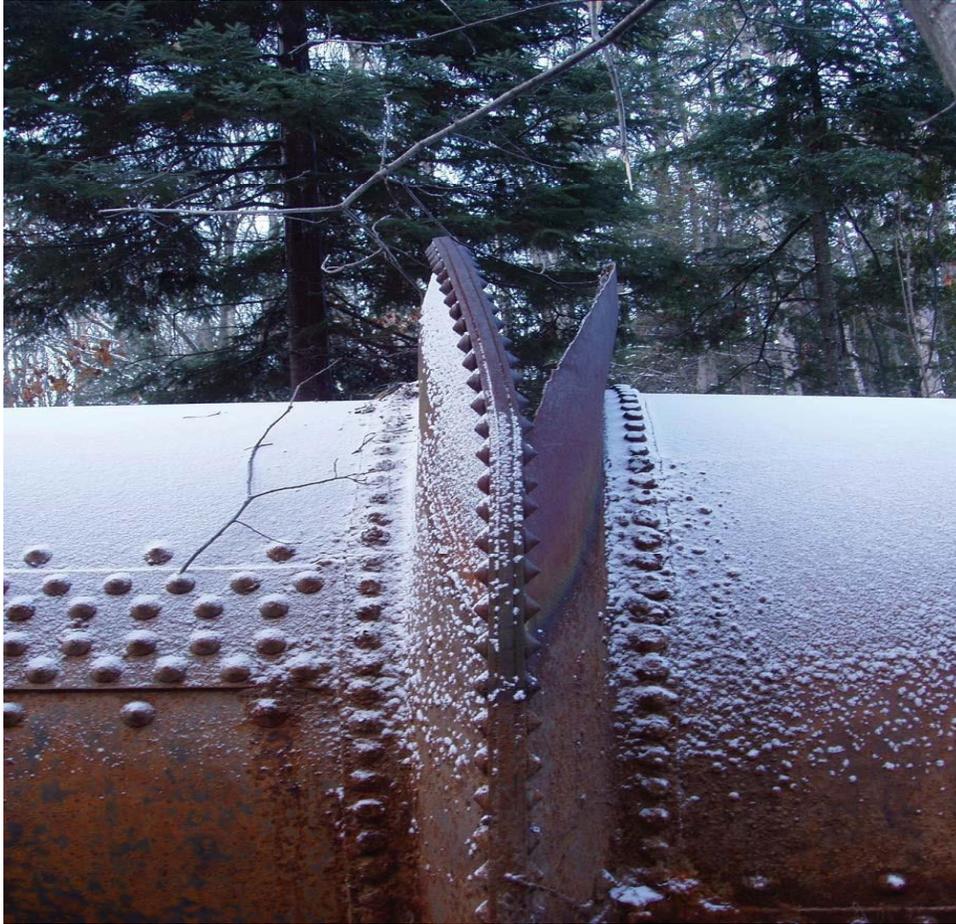
Some older penstocks under FERC jurisdiction have bellows expansion joints. Bellows joints are typically used on low pressure penstocks, in which the flexibility of the flanges is expected to accommodate the expansion and contraction that occurs within the penstock. This type of joint is subject to fatigue and therefore can be problematic.

Fig. 6. Failed bellows expansion joint.

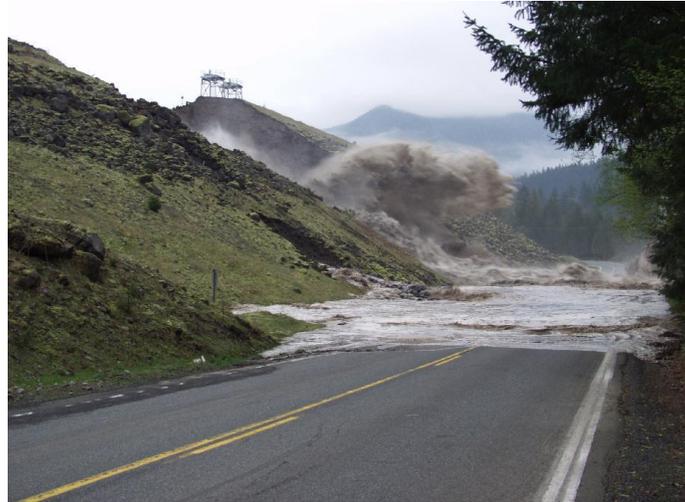
The following photo depicts the failure of the Swift #2 Power Canal in 2002. The canal embankment (photo left side) failed due to piping into a rock fissure in the canal foundation. The hazard potential of elevated power canals can clearly be seen in this photo.

Fig. 8. Swift #2 Power Canal failure.

Because of the length of many power canals, there may not have been an extensive foundation exploration and testing program prior to the canal's construction. It is likely that the canal passes over natural ground that has sand seams or rock joints or other features that could lead to a piping failure. Note the fissure that lead to the piping failure of the Swift #2 Power Canal embankment.

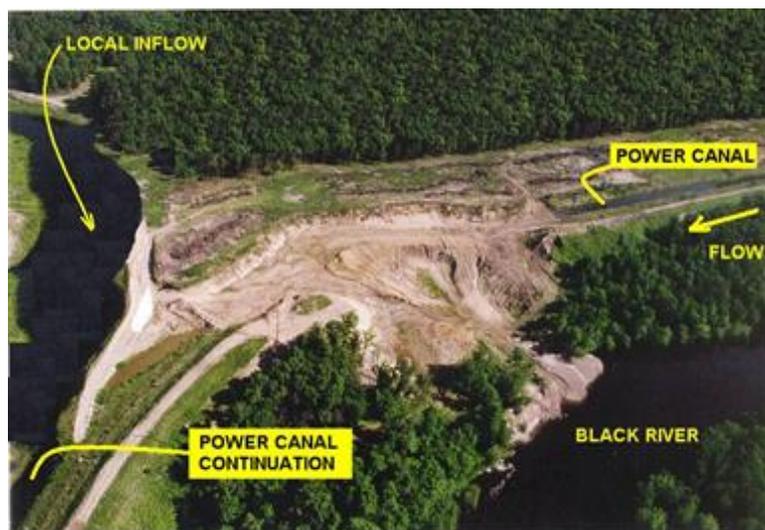
In the case depicted below, embankment overtopping occurred as a result of a combination of high inflow through the upstream headgate structure and inflow from a stream that was a tributary to the power canal (Hatfield Project, Wisconsin, 1993).

Fig. 9. Hatfield power canal failure.

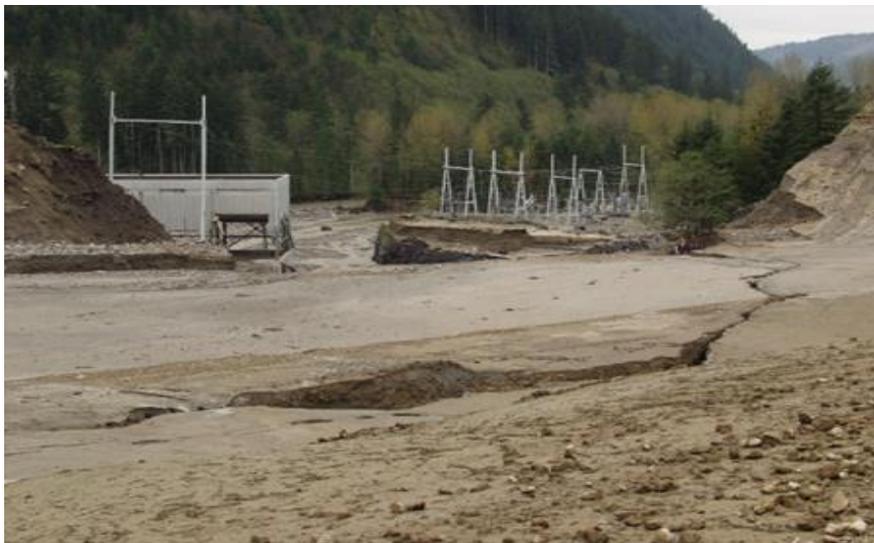
Fig. 11. Fissure at Swift #2 Power Canal.

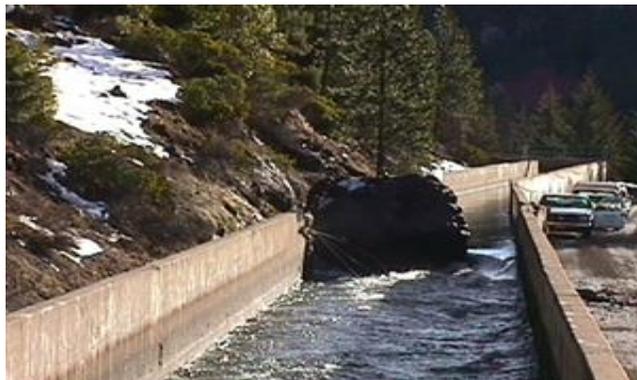
When canals are in areas of steep unstable slopes, rockfalls and landslides can damage or plug the canal as can be seen in Figure 13.

Fig. 13. Rock inside power canal.

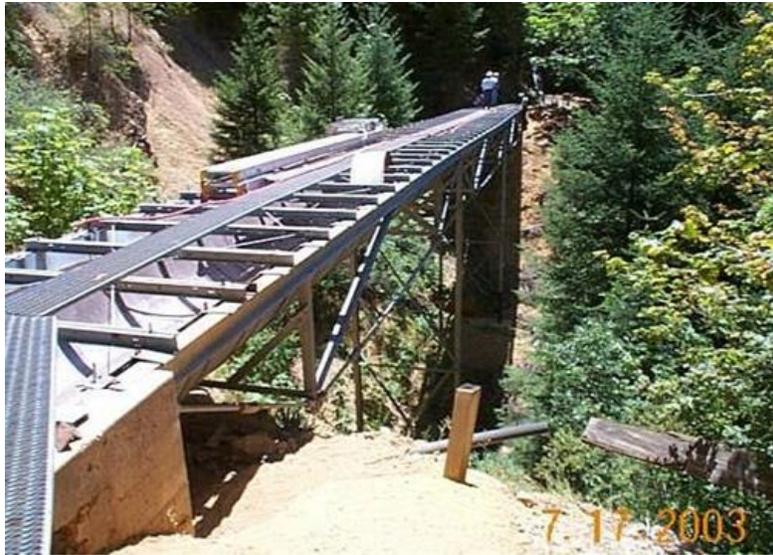
Flumes are basically elevated canals supported by some sort of structure (Figure 14). Since flumes are gravity flow conveyances with open tops, their sides can be overtopped. They can fail due to erosion of their foundations. Like penstocks, they are often in areas of high relief where landslides, mudslides and mass wasting can fail them.

Fig. 14. Typical flume.

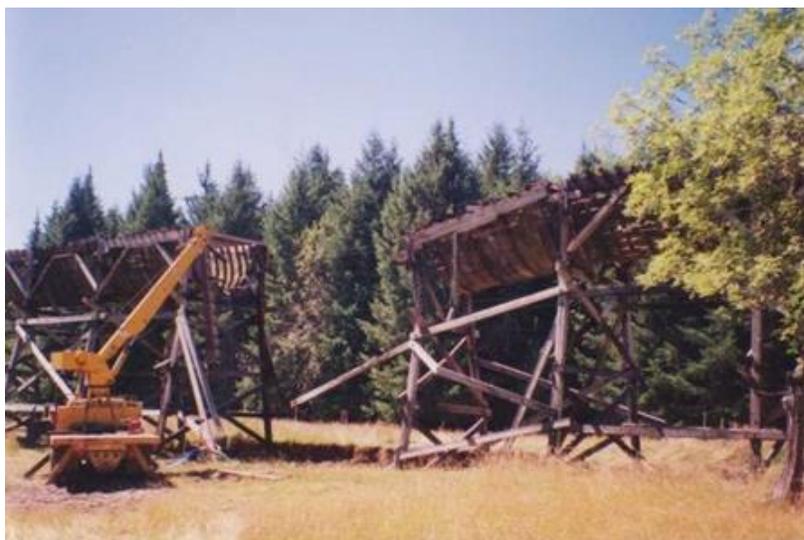
Flumes are often supported by wooden railroad style trestles or steel bridge trusses. In addition to the failure modes discussed above, wooden flumes are also susceptible to fire, insects and wood rot.

Fig. 15. Failed flume.

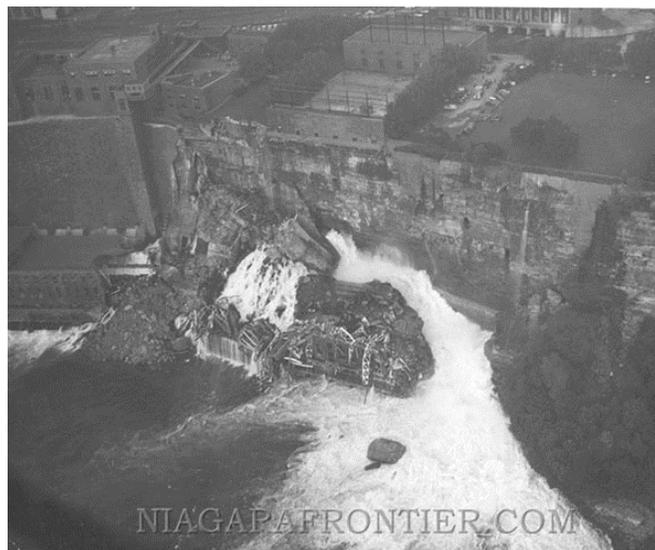
Figure 18 depicts the 1956 Schoellkopf Power Station failure (Niagara Falls). This rockslide was caused by unlined power tunnels, which allowed for pressurization of rock joints in the steep rock mass behind the powerhouse. The powerhouse was destroyed and one powerhouse worker was killed. This is an example of a failure mode that can plague power tunnels near their downstream ends.

Fig. 18. Schoellkopf Power Station failure.

The Schoellkopf Power Station failure occurred suddenly with almost no warning signs after 50 years of satisfactory performance. This suggests that monitoring techniques like piezometers, crack meters and surveys would not be very helpful. If the bluff geometry and joint pattern suggest a potential for instability and joint pressurization can occur, intercepting rock joints with drain holes around the circumference of the tunnel may be a prudent measure.
