Identifying, Describing, and Classifying Potential Failure Modes

Dam Safety Risk Analysis Best Practices

U.S. Department of the Interior
Bureau of Reclamation

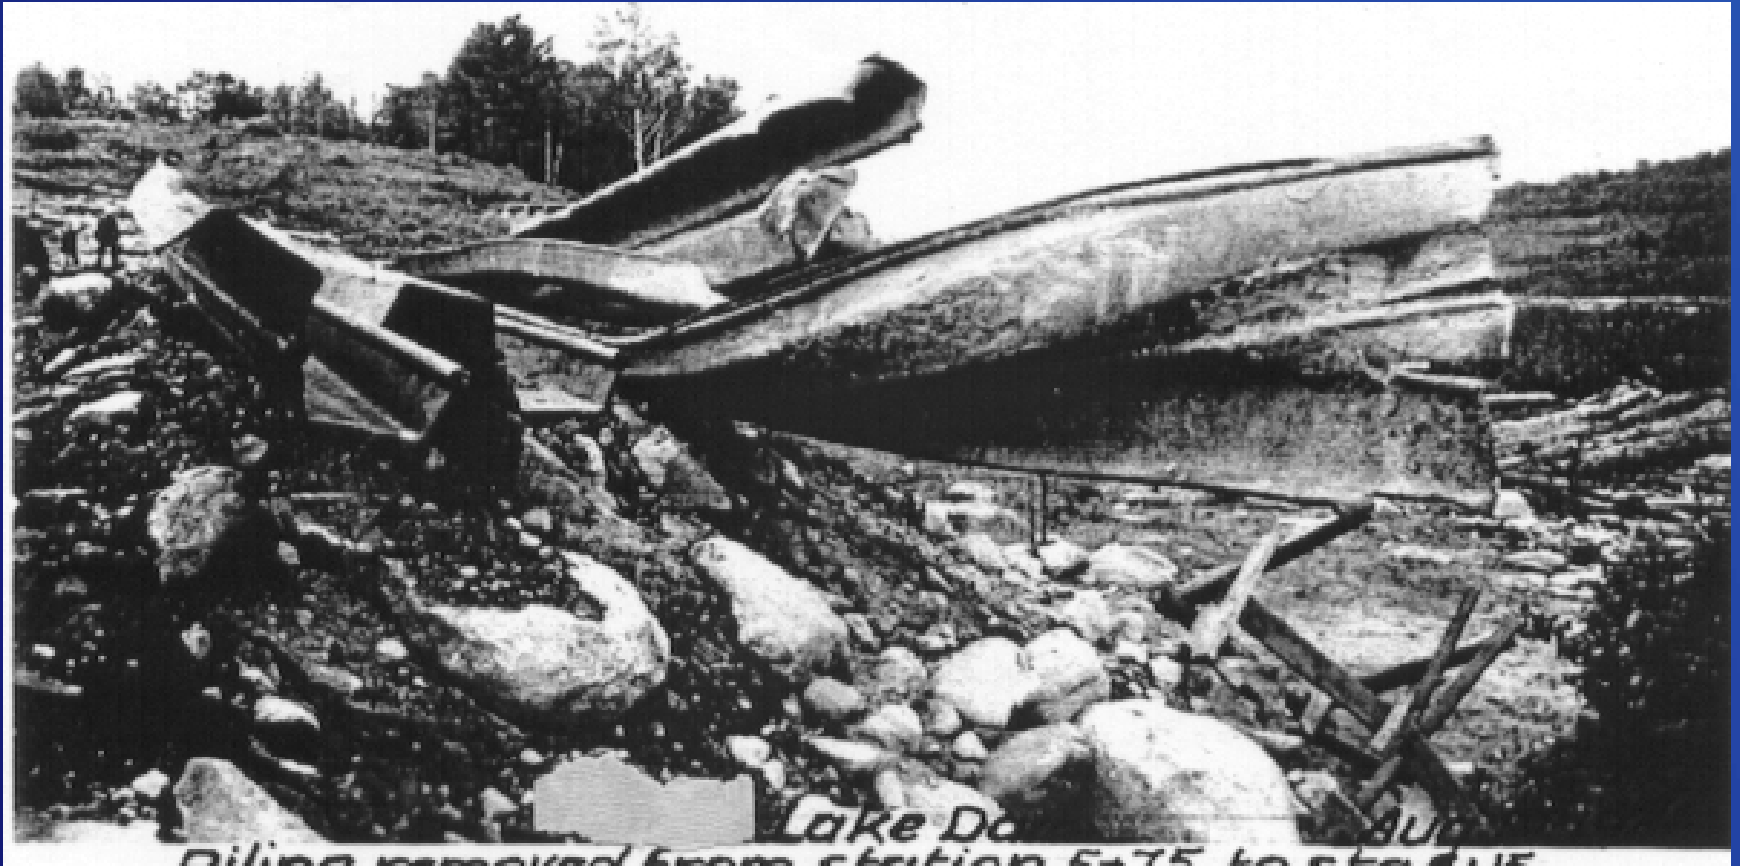
Identifying and Describing

- Unedited (insufficient detail): **Piping from the embankment into the foundation**
- Edited: **During a period of high reservoir elevation, piping of the embankment core initiates at the gravel foundation interface in the shallow cutoff trench near Station 2+35 (where problems with the sheet pile and sinkhole occurred). Material might or might not exit at the toe of the dam. Backward erosion occurs until a “pipe” forms through the core exiting upstream below the reservoir level. Rapid erosion enlargement of the pipe occurs until the crest of the dam collapses into the void, and the dam erodes down to the rock foundation.**

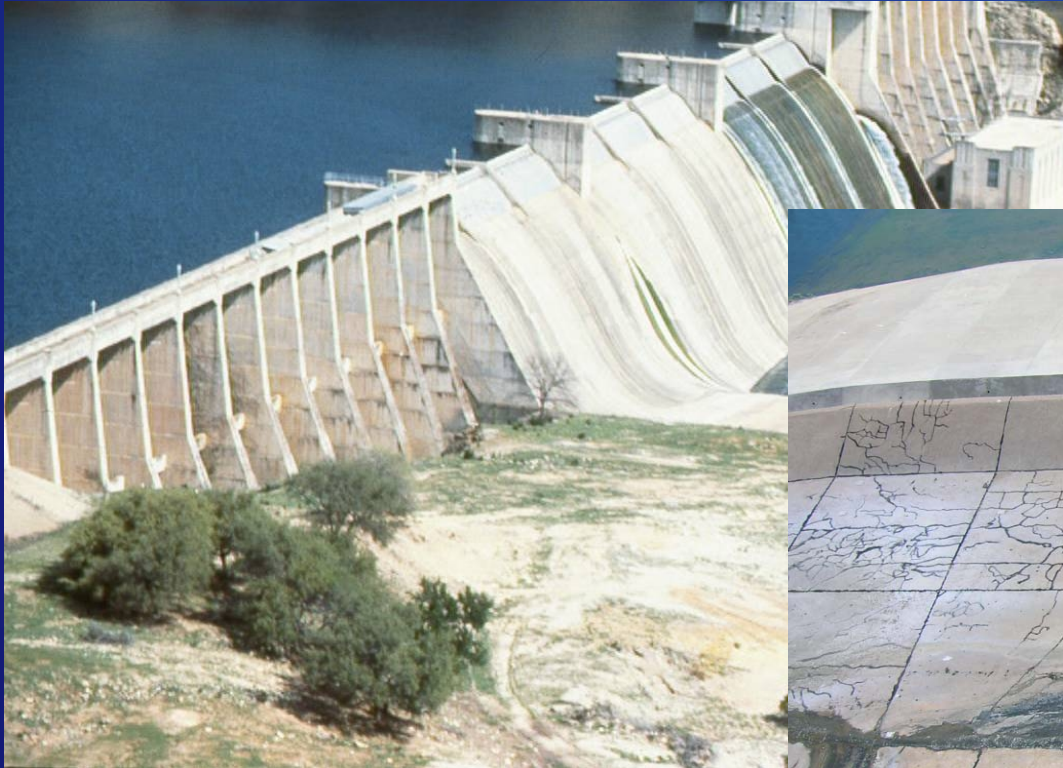
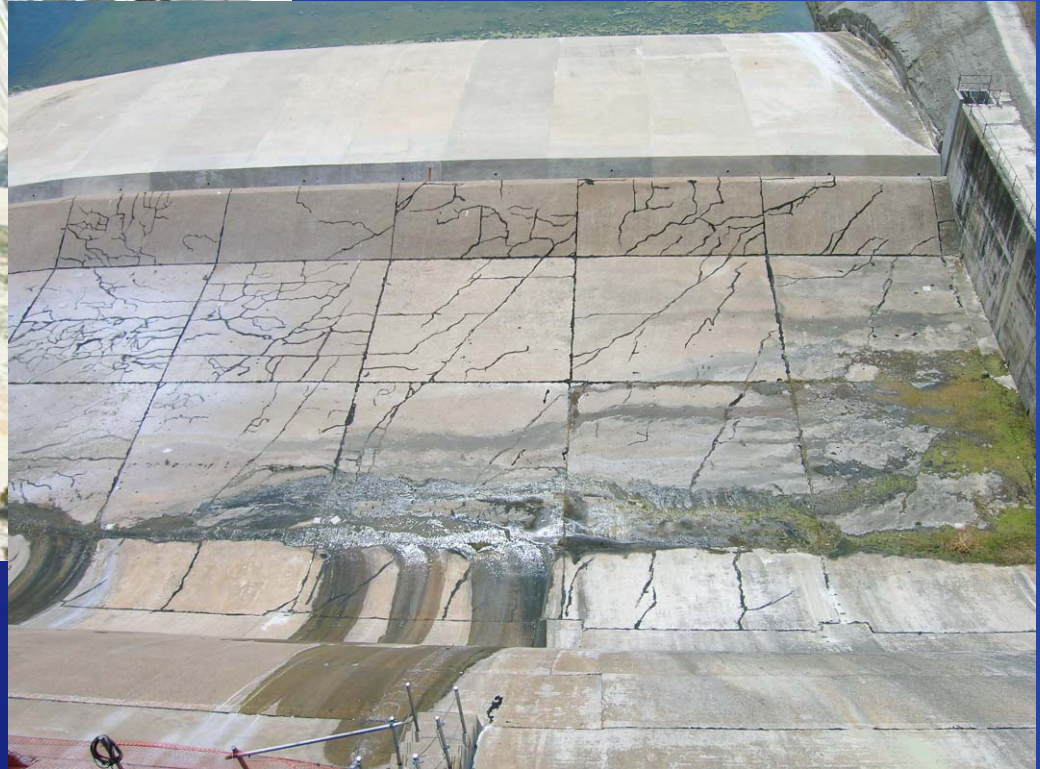
Surveying results indicated the dam had moved several inches since monitoring began

- Unedited (insufficient detail): **Sliding of the concrete dam foundation**
- Edited: **As a result of high reservoir levels and (1) a continuing increase in uplift pressure on the shale layer slide plane, or (2) a decrease in shearing resistance due to gradual creep on the slide plane, sliding of the buttresses initiates. Major differential movement between two buttresses takes place causing the deck slabs to be unseated from their simply supported condition on the corbels. Breaching failure of the concrete dam through two bays quickly results followed by failure of adjacent buttresses due to lateral water load.**

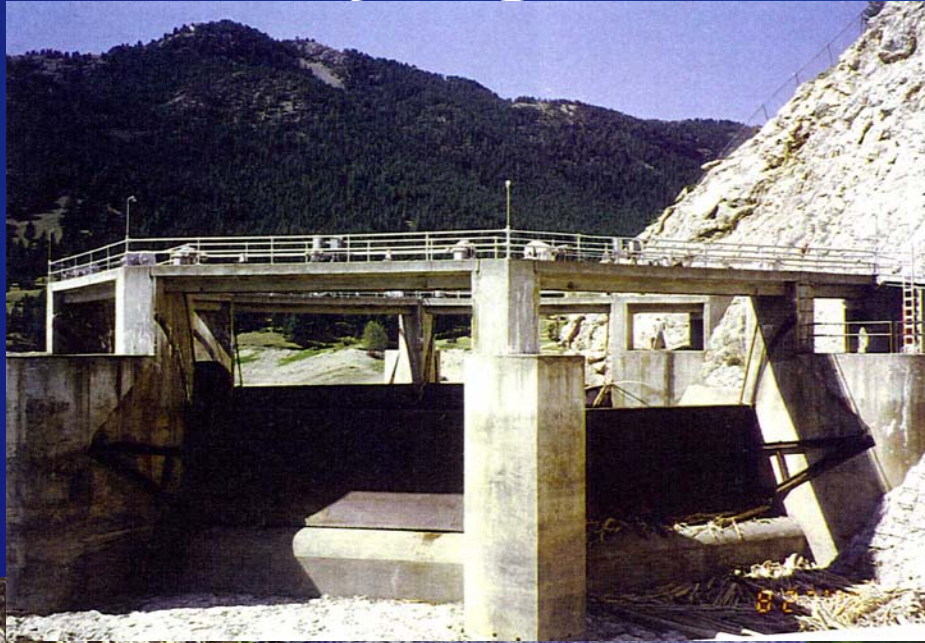
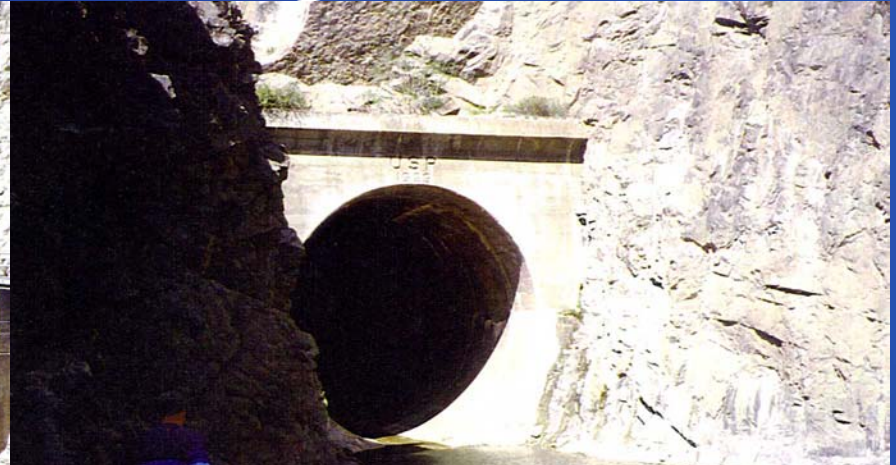
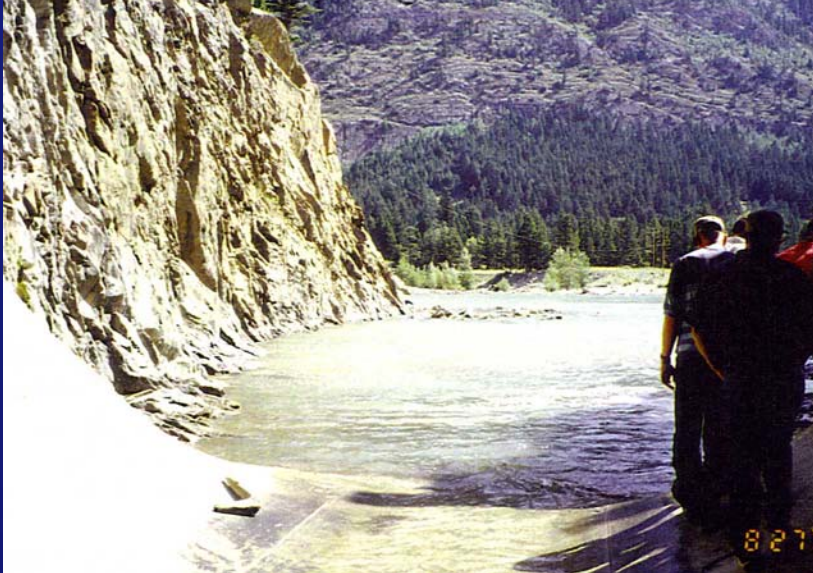
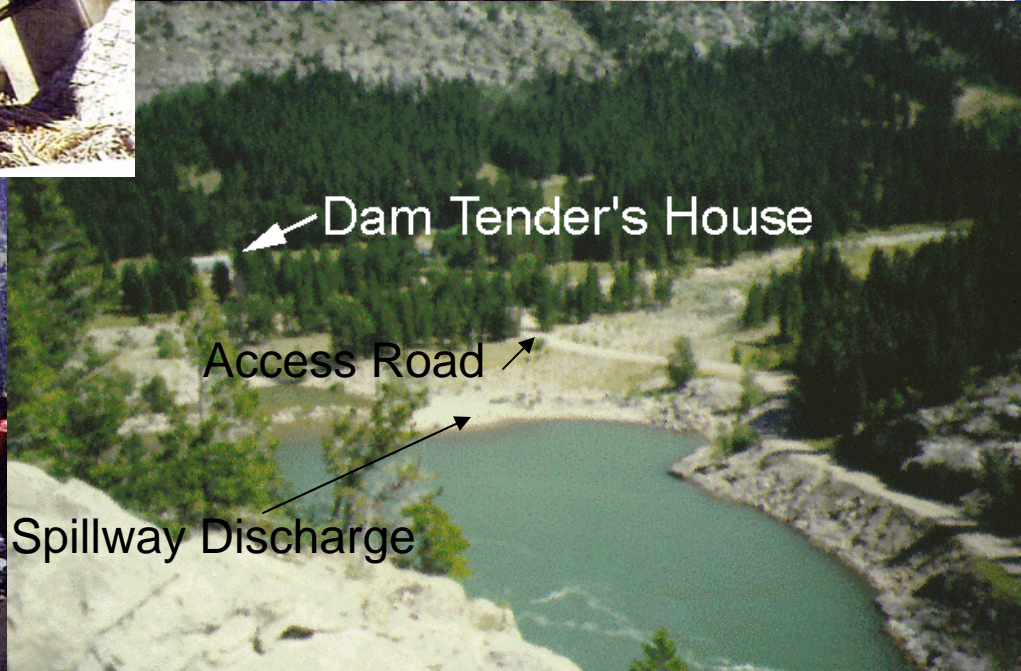
- An embankment dam has a gated spillway crest for passing flood flows. Of the four gates, one can be remotely operated from the power control center to pass normal flows. The remaining three gates must be operated manually from a control house on top of the spillway hoist deck. If a single gate is opened completely, the main access road is inundated. A limit switch keeps the remotely operated gate from opening more than half way without on-site intervention. The limit switch failed in 1994 and the road was washed out. The only other access to the spillway gate deck is a rough 4-wheel-drive road from the reservoir side that becomes muddy and treacherous when it rains.

- Unedited (insufficient detail): **Dam overtopping due to gate operation failure**
- Edited: **During a large flood, releases in excess of those that can be passed through the automated gate are required. The limit switch on the automated gate fails (occurred in 1994) due to a loss in communications and the gate opens fully wiping out the only access road. An operator is deployed to the site, but cannot make it to the gate operating controls. The release capacity of the single automated gate is insufficient and the dam overtops, eroding down to the stream level.**
