Simplified Risk Analysis Overtopping of West Pass Dike Upper Baker Development, Baker River Project, P-2150

RIDM Level 1 Workshop – Spring 2012

Upper Baker Dam is a 297-foot-high, "High" hazard concrete gravity dam, with a 285,500 acre-foot reservoir. Located in northwestern WA near Canada.

West Pass Dike is a 115-foot-high earth and rockfill saddle dam located near the right abutment.

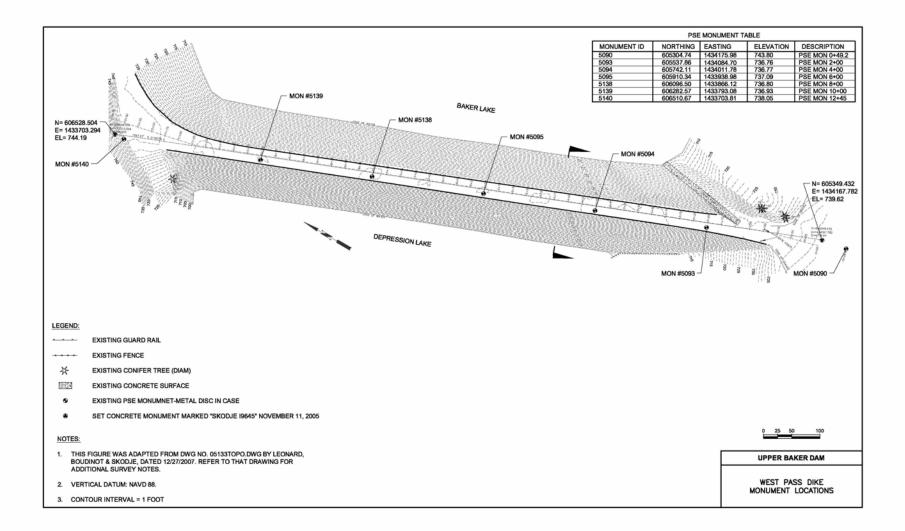
West Pass Dike - Rolled Rockfill

There is no clear description or measured soil gradations of the rolled rockfill

Based on visual observation it consists of sandy gravel with cobbles

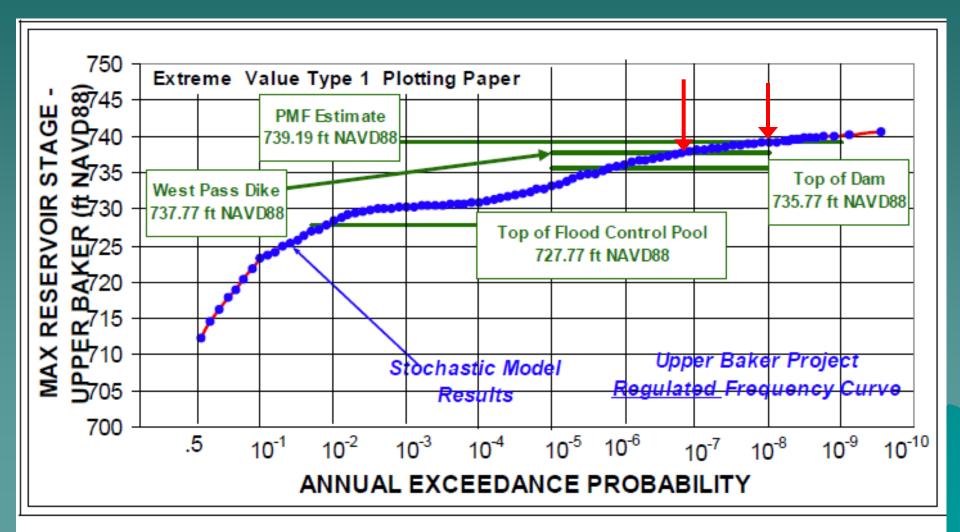
Frequency of Maximum Reservoir Level

Figure 6-10. Flood-Frequency Curve for Upper Baker Dam – Maximum Reservoir Elevation

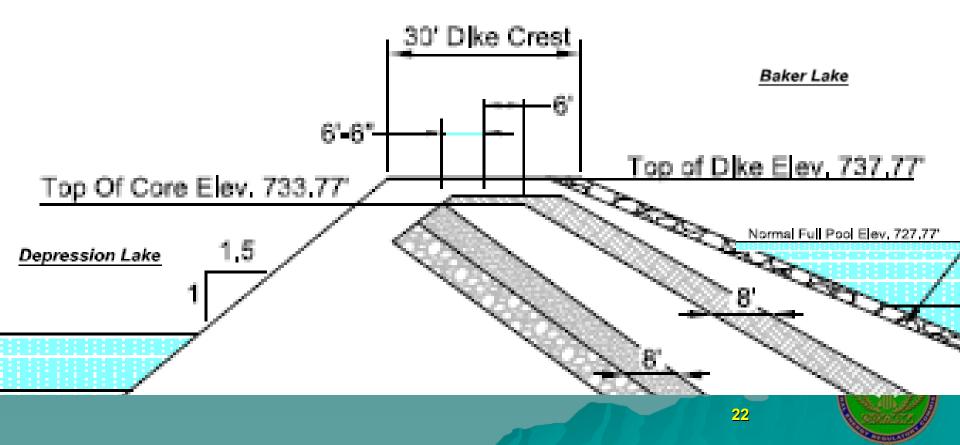
- PMF occurs and flood begins to overtop West Pass Dike.
 - At some ? overtopping elevation West Pass Dike begins to erode.
 - Erosion continues as flood continues and breach develops.
 - Breach erodes West Pass
 Dike to the near the foundation.

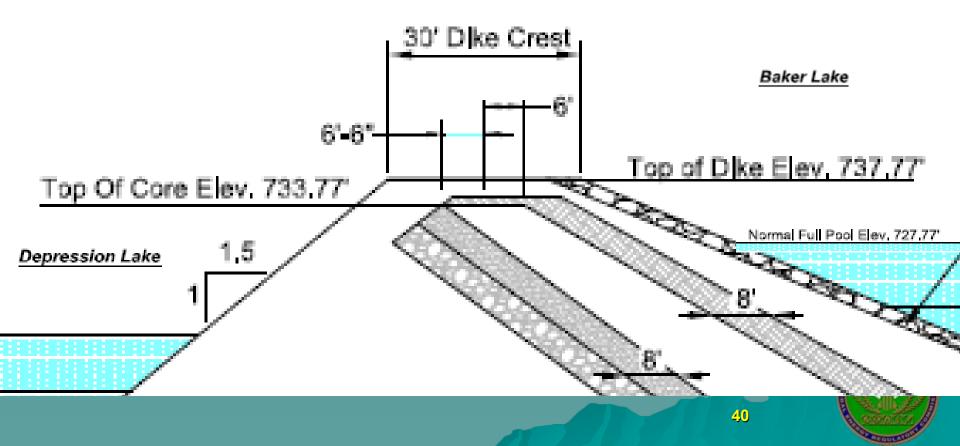
- PMF occurs and flood begins to overtop West Pass Dike.
 - At some ? overtopping elevation West Pass Dike begins to erode.
 - Erosion continues as flood continues and breach develops.
 - Breach erodes West Pass
 Dike to the near the foundation.
